# Okemos Public Schools

Facilities Assessment

September 2018

# Kingscott

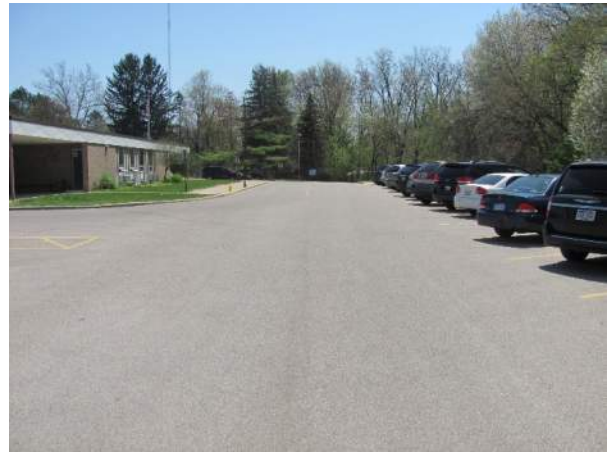
##### Paving:

Entry drive was repaved in 2009 and appears to be in good condition. North and South lots were repaved in 2011 and in good condition. With proper maintenance and light duty traffic, paving should be serviceable for the next 10 - 15 years. 'Magic Square' hard surface play is in fair condition. Multiple cracks observed. Recommend repaving in next 5 years. Site concrete in fair condition. Recommend allowance to reconstruct select concrete walks.

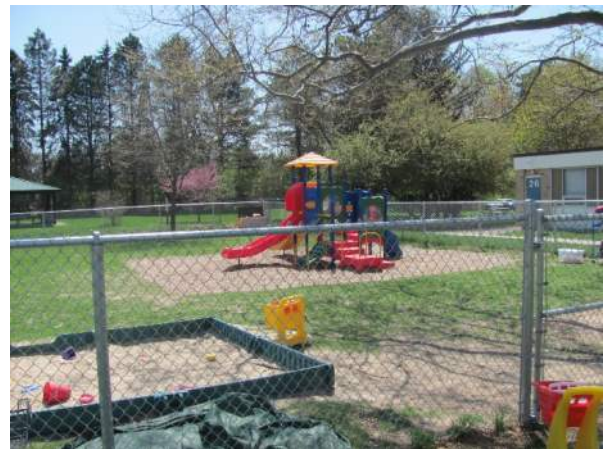
##### Playgrounds:

Playground equipment is in fair condition. Structures replaced in 2002. Some replacement may be required. District maintains and adds surfacing yearly. Provide allowance for new playground structures.

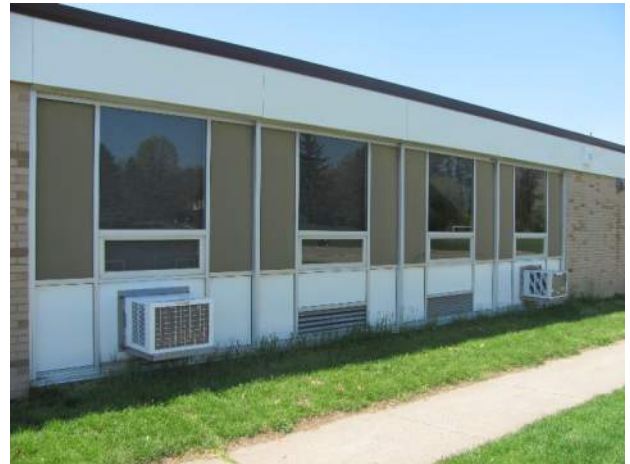
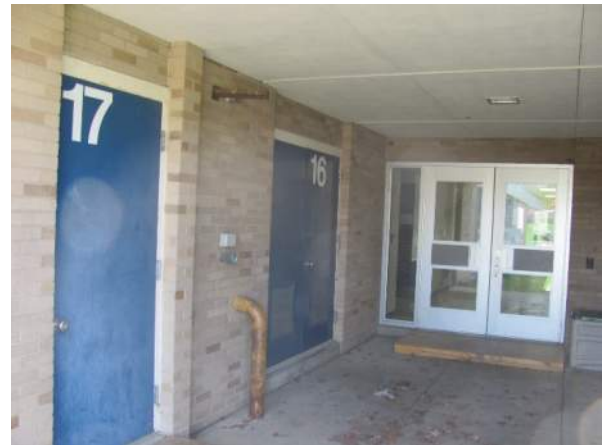
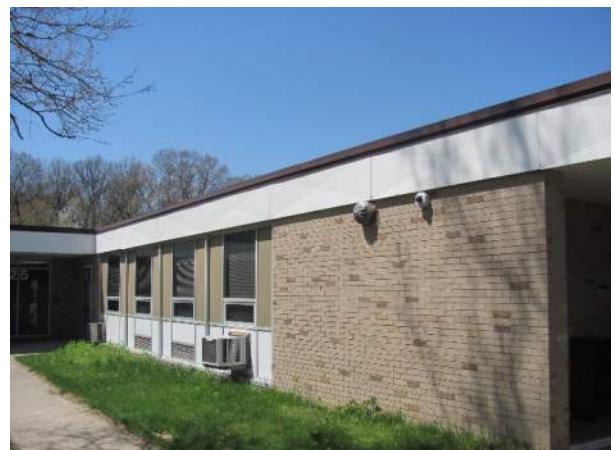
Generally, the roofs are in good condition with single-ply adhered EPDM roofing membranes installed in 2006, 2007 and 2008. If maintained properly, roofing should be serviceable for 10 - 15 years.

Existing brick envelope with metal panel fascia is in excellent condition with no issues noted.

Aluminum window systems with integral blinds appear to be in good condition. Note window AC units should be replaced with new AC system. Existing storefront entrances are all in excellent condition. No issues noted.

Existing HM doors/frames are in fair condition. Eventually HM doors/frames rust and should be replaced w/Alum/FRP doors/frames.

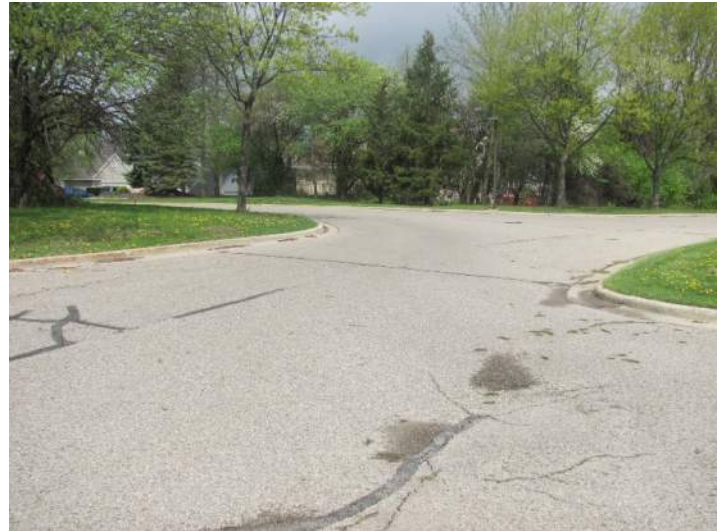
###### **Paving:**

South drive was repaved in 2006 and in fair to poor condition. Some cracks were observed. Recommend repaving in next 5 years. Main entry and drive in front of office was repaved in 2007 and in fair to poor condition. Some cracks were observed. Recommend repaving in next 5 years. Main lot was repaved in 2008. Lot is in fair condition. Multiple cracks observed. Recommend repaving lot in next 5 years. Bus drive was repaved in 2009 and is in good condition. With proper maintenance it should be serviceable for the next 5 - 10 years. A new lot at the north end was constructed in 2014 and in excellent condition. With proper maintenance it should be serviceable for the next 10 - 15 years. Magic Square is in good condition and should be serviceable for next 5 - 10 years. Site concrete in fair condition. Recommend allowance to reconstruct select concrete walks.

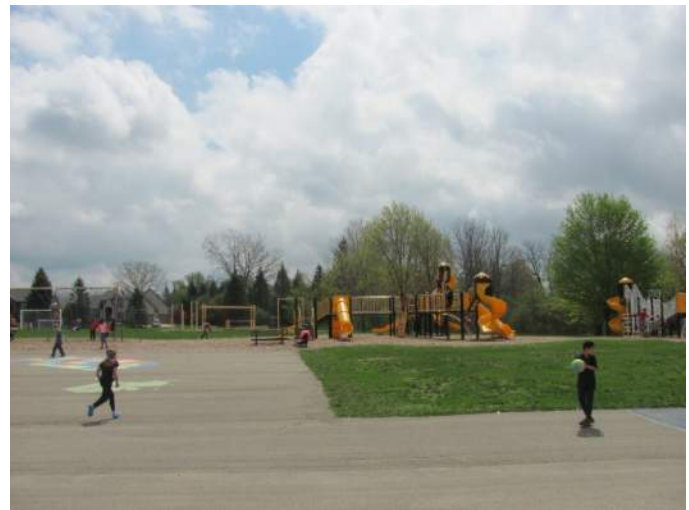
###### **Playgrounds:**

Playground equipment in fair condition. Structures replaced in 2002 and 2006. Some replacement may be required. District maintains and adds surfacing yearly. Provide allowance for new playground structures.

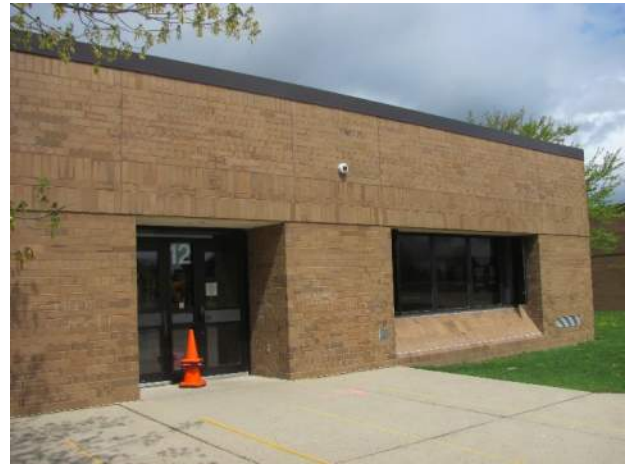
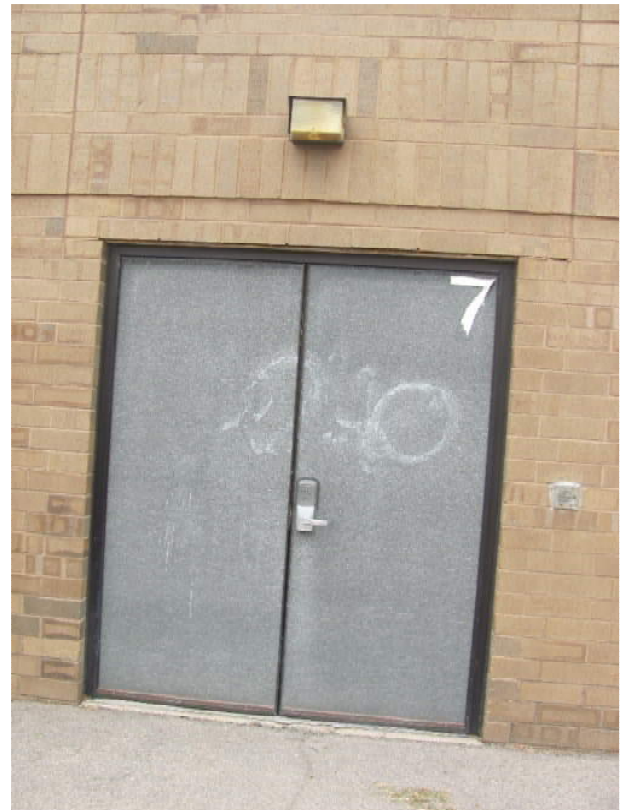
Existing HM doors/frames are in fair condition. Eventually HM doors/frames rust and should be replaced w/Alum/FRP doors/frames. Replace HM sidelights and transoms associated with new interior vestibule doors with aluminum frames and security glazing.

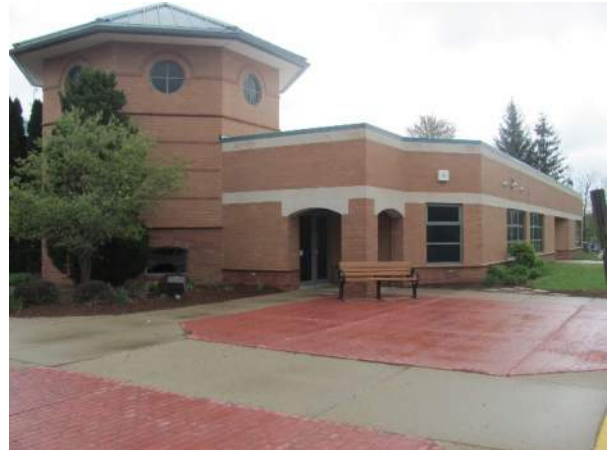
Site appears to be well drained with the exception of the interior courtyard near the front where water has been reported to drain into the corridor with heavy rains. Regrade and landscape this area with a drainage structure.

Existing masonry chiller screen wall is deteriorating. Recommend removal and replacement.

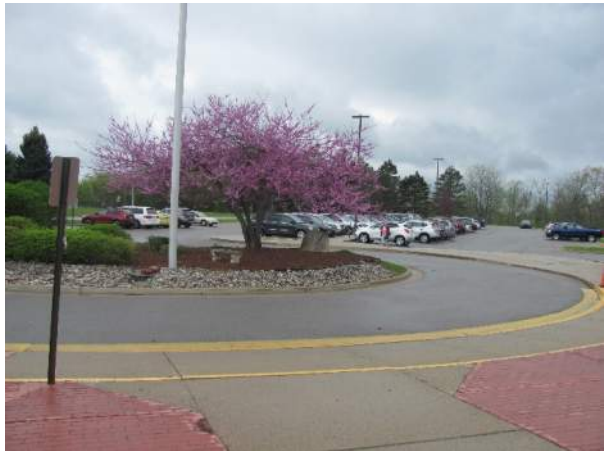
##### Paving:

Drives and lots repaved in 2013 and in excellent condition. With proper maintenance lots should be serviceable for another 10 - 15 years. Site concrete in fair condition. Recommend allowance to reconstruct select concrete walks. Brick pavers at entrance are deteriorating. Could be a potential trip hazard. Recommend replacing with stamped, colored concrete.

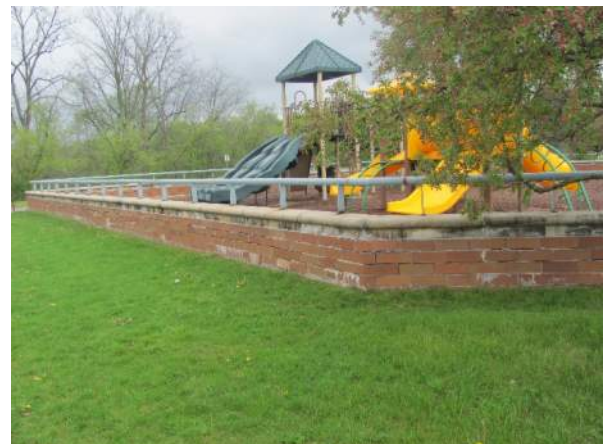
##### Playgrounds:

Playground equipment is in fair condition. Structures replaced in 2002. Some replacement may be required. District maintains and adds surfacing yearly. Provide allowance for new playground structures. Existing masonry playground wall is deteriorating. Recommend removal and replacement with decorative steel fence.

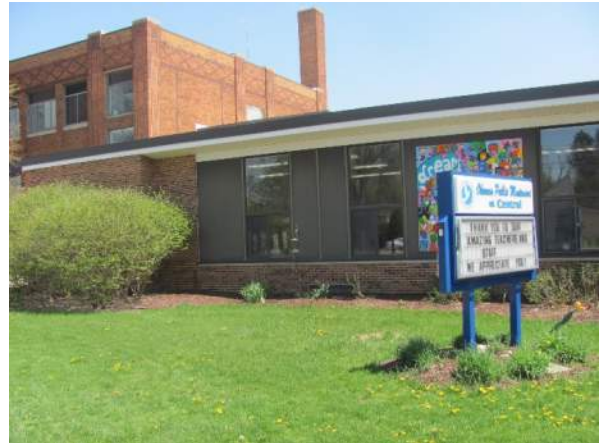
Existing modular brick envelope appears to be in good condition with no reported problems.

Window systems appear to have been replaced in the late 1970s/early 1980s with a great majority of the openings covered with panels, presumably to save energy. As long as parts are available and windows are weather tight, recommend keeping existing window systems.

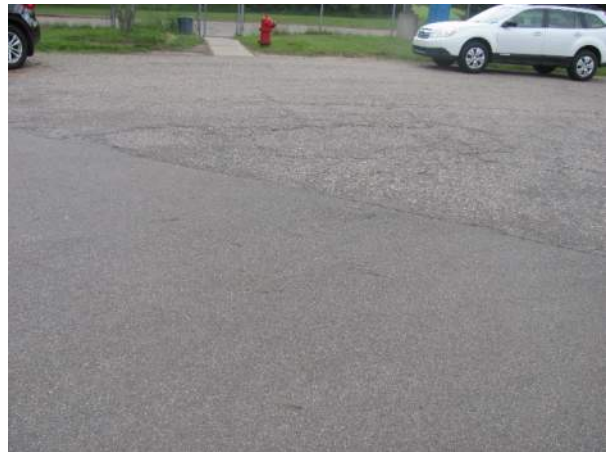
##### Paving:

The north bus parking lot was repaved in 2016 and is in excellent condition. With proper maintenance, paving should remain serviceable for 15 - 20 years. Existing entrance drive is showing signs of wear with cracks. Re-pave in next 5 years with HD pavement. Existing pavement in front and rear of garage is showing signs of wear with cracks. Re-pave in next 5 years with HD pavement. Existing employee lot is showing signs of wear with cracks. Re-pave in next 5 years with standard pavement.

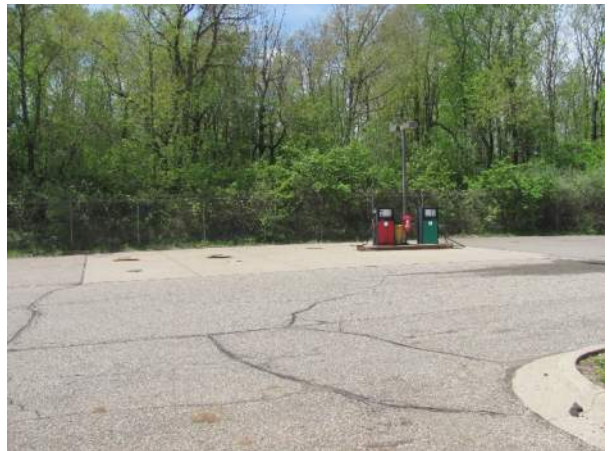
Existing underground fuel tanks require expensive monthly environmental monitoring. Recommend removal and replacement with above ground station and containment.

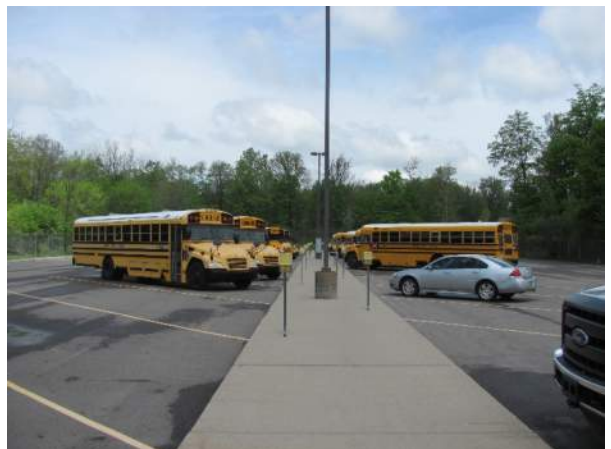
##### Bus Parking:

Busses are parked in the open with no protection from ice/snow. Recommend a canopy to keep windshields clear and driver safety.

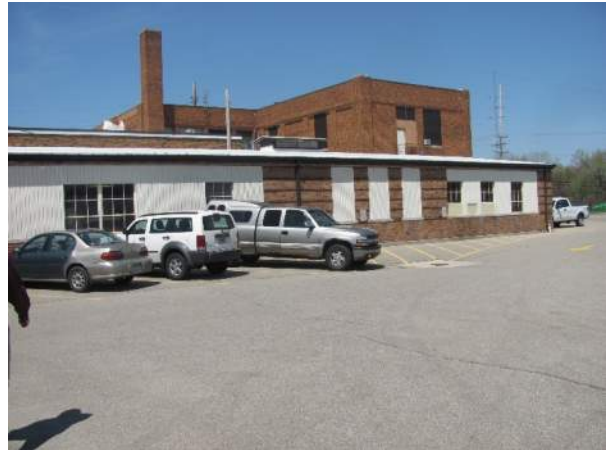
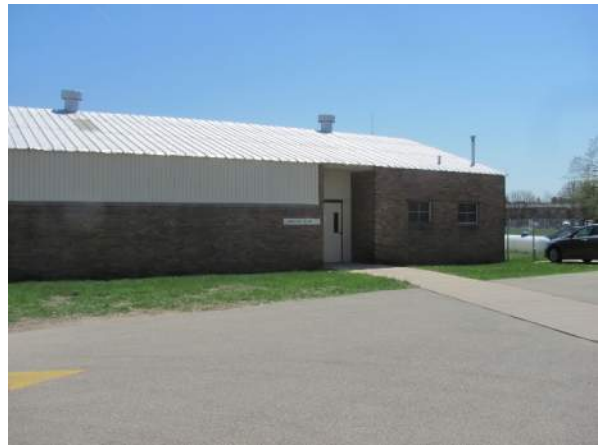
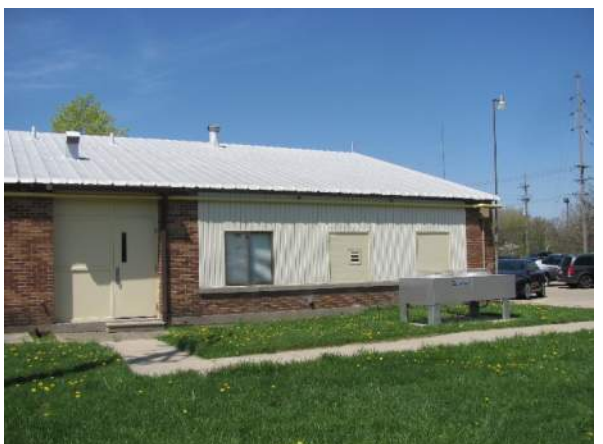
Replace existing exterior windows.

Replace existing HM service doors/frames w/Alum/FRP doors/frames. Replace existing vestibule doors/frames w/Alum doors/frames.
