# Okemos Public Schools

Facilities Assessment

September 2018

# Kingscott

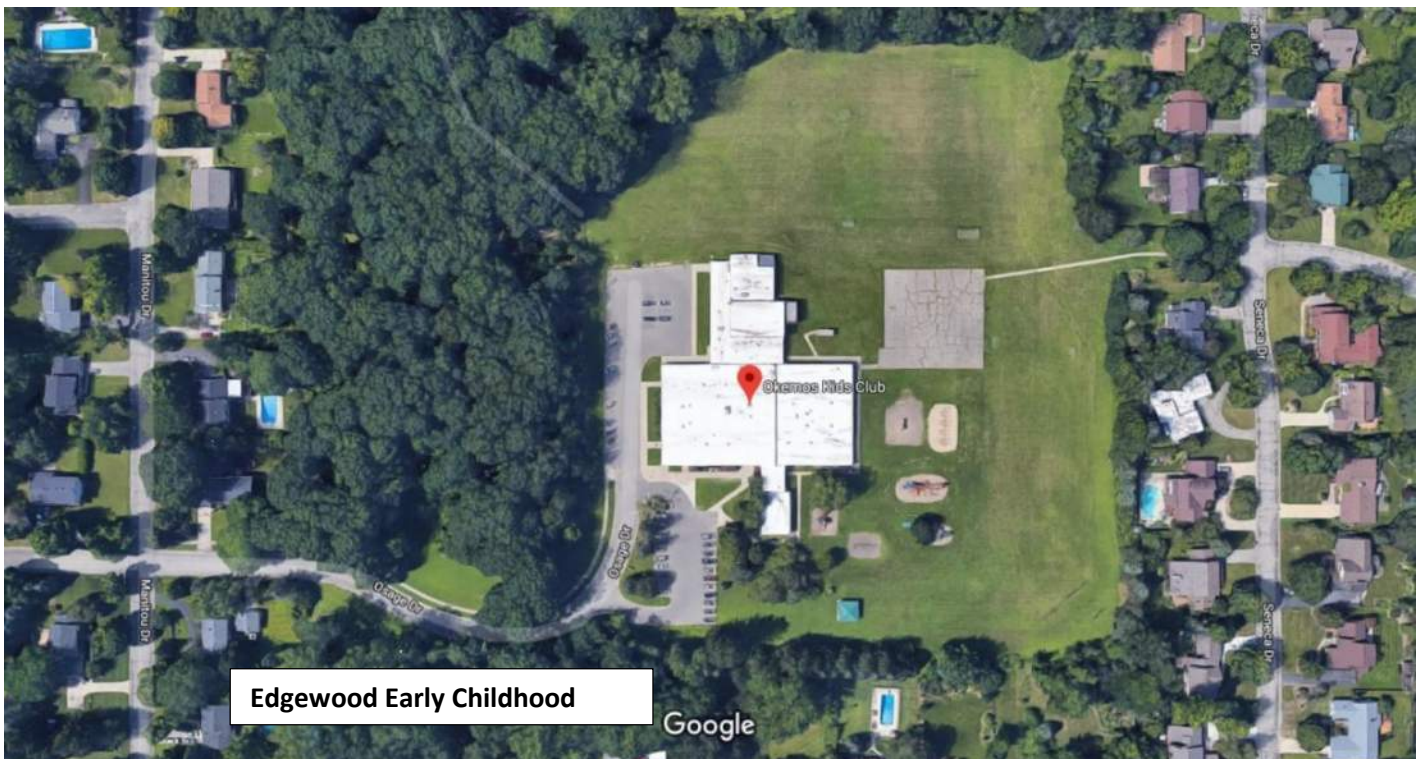
The 12-acre Edgewood site is set in a residential area. Site access is from a single entrance drive from Osage Lane, just off Manitou Road. Since there is no bus traffic, parents typically park and walk kids into building. Site is well maintained with no known issues. Playground equipment in fair condition. Structures replaced in 2002. Some replacement may be required. District maintains and adds surfacing yearly.

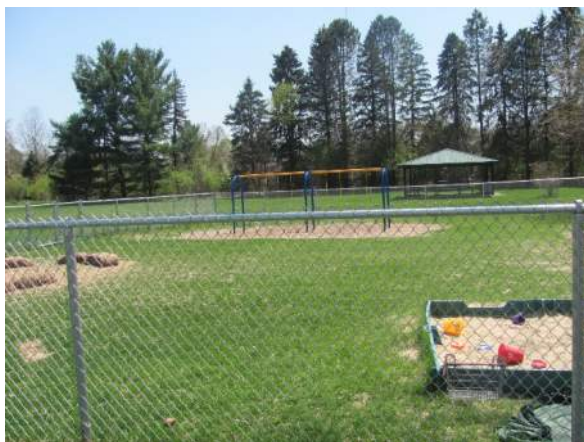
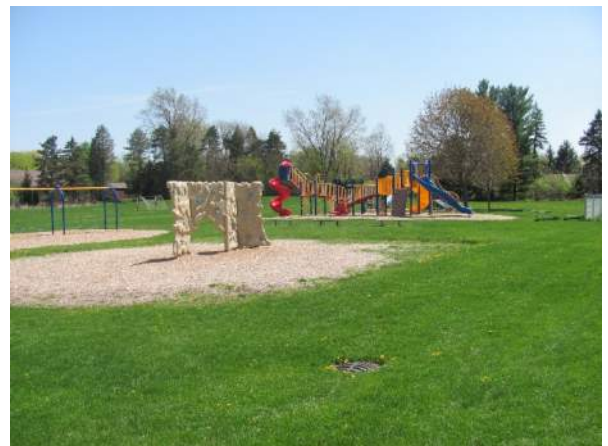
Playfields are in good condition. No issues noted.

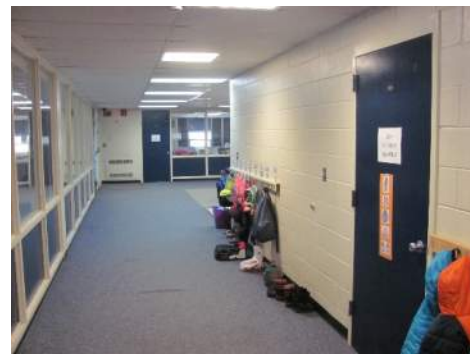
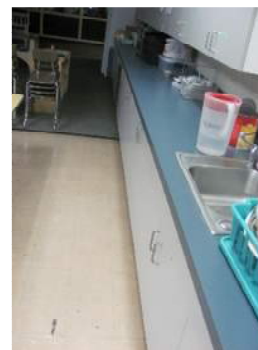
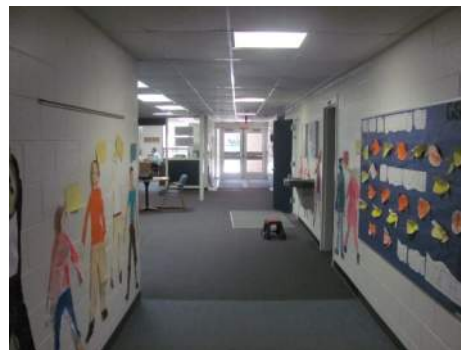
Building has secure entrance with electronic locks and recently installed camera system to control main entrance. The building has a web-based security camera system throughout building. There is not a secure vestibule into the main office. There does not appear to be door contacts to notify when exterior doors are compromised. Consider secure vestibule, security window film and door contacts in program improvements.

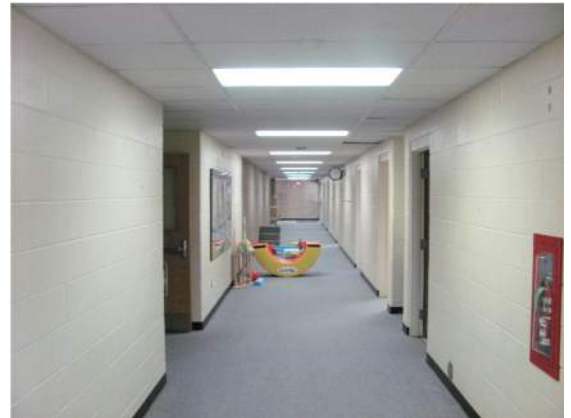
Interior walls for the most part are painted concrete masonry units (CMU) with some gypsum board partitions/bulkheads. All are well maintained and other than routine patching, maintenance/painting especially at the drywall partitions, no major work is currently necessary.

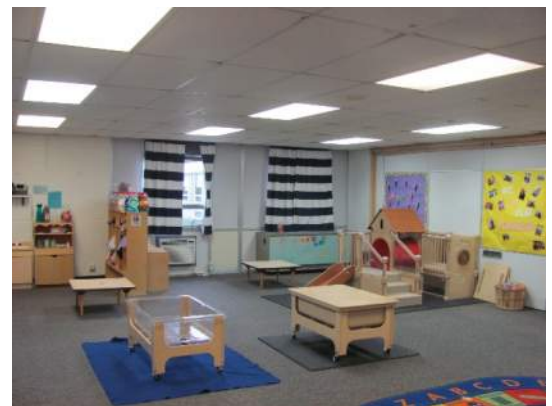
Ceilings are mainly suspended acoustical 2 x 4 panels, gypsum board and exposed metal deck and are in good serviceable condition. No issues noted

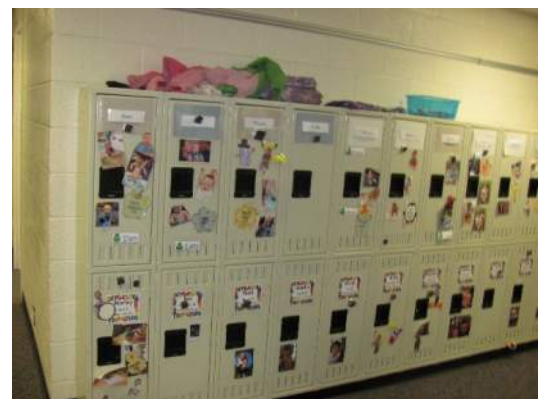
Corridor Lockers are in good/fair condition. No issues noted.

Existing classroom classroom storage cabinets are generally in good condition. No issues noted.

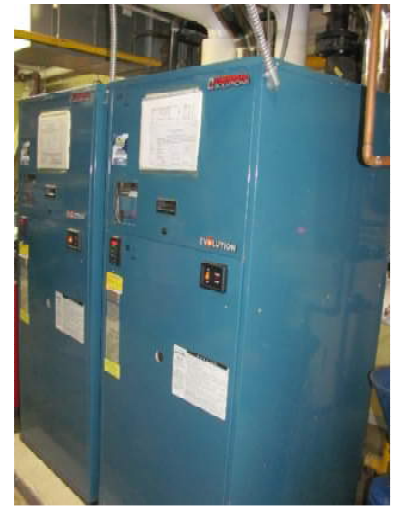
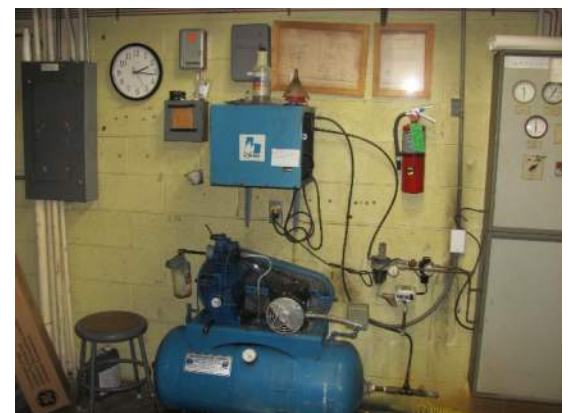
Exhaust systems are original to building and should be replaced.

Replace existing pneumatic temperature controls with new DDC system to communicate with district's system. Replace CO2 sensors.

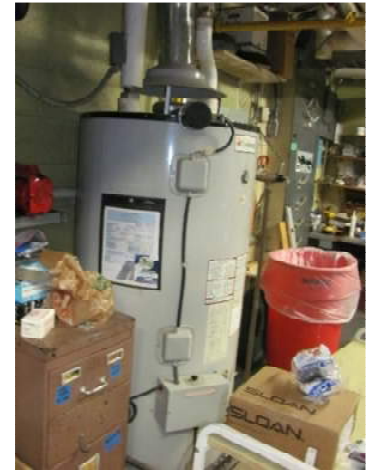
Domestic water heater is a 100 gallon, 199 Mbh, serves building well and is in good condition. Water heater is 18 years old and may need replacement in 5-10 years.

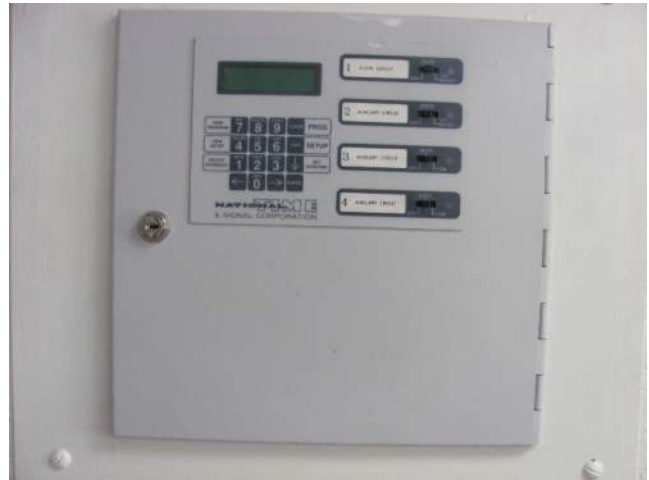
The original clock system is inadequate and recommended for replacement.

Sound systems – no issues noted.

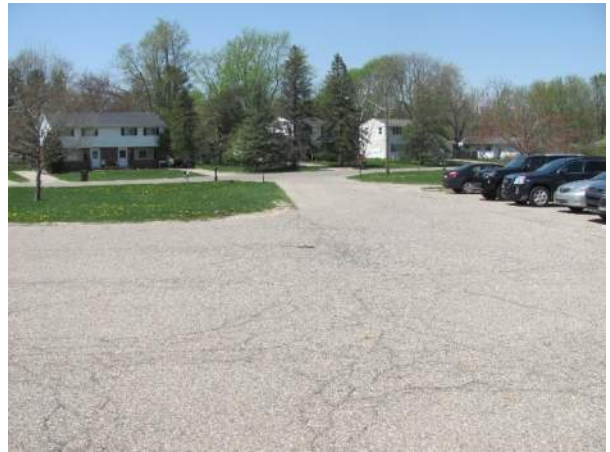
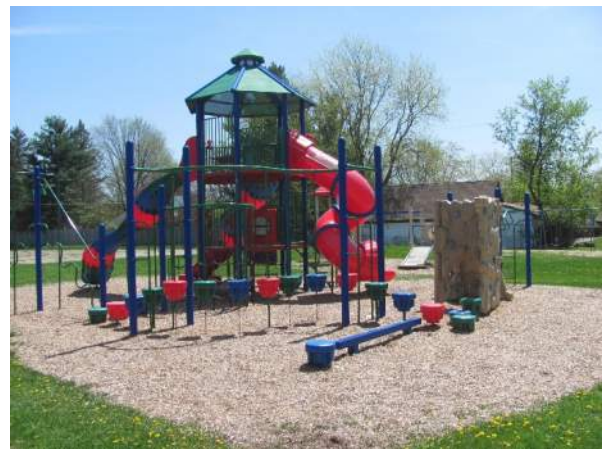
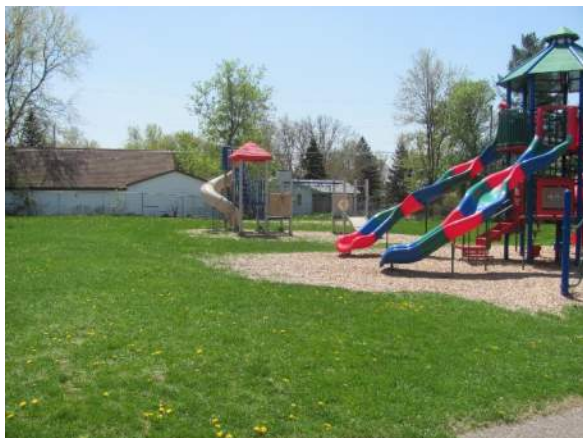
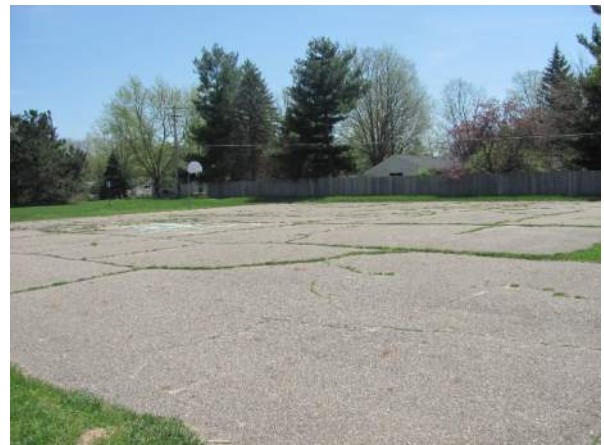
Playground equipment in fair condition. Some replacement may be required. District maintains and adds surfacing yearly.

Playfields are in fair condition. No issues noted.

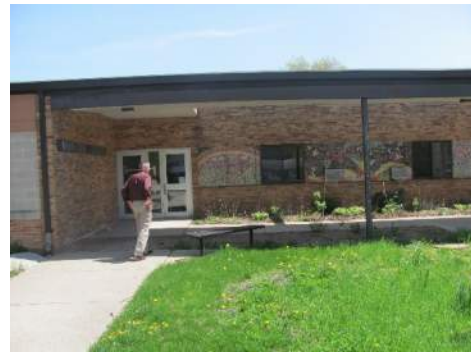
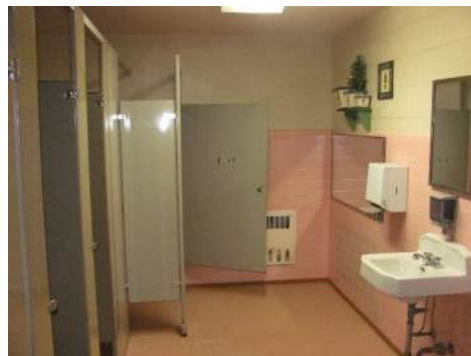
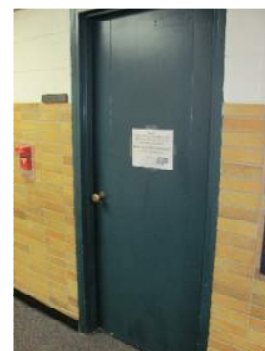
There is not a secure vestibule into the main office. Remodel and add to entrance and Principal office to direct visitors through office reception.

There does not appear to be door contacts to notify when exterior doors are compromised. Consider secure vestibule, security window film and door contacts in program improvements.

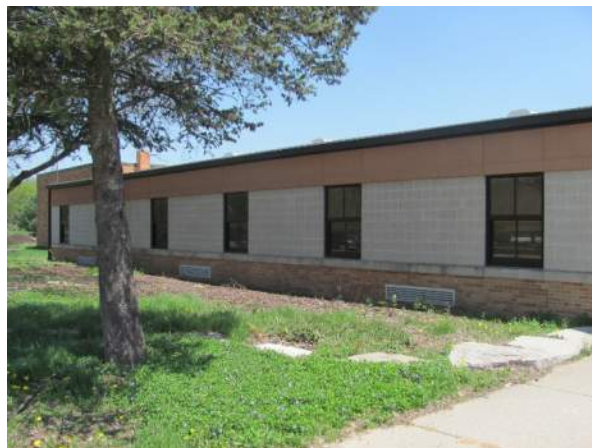
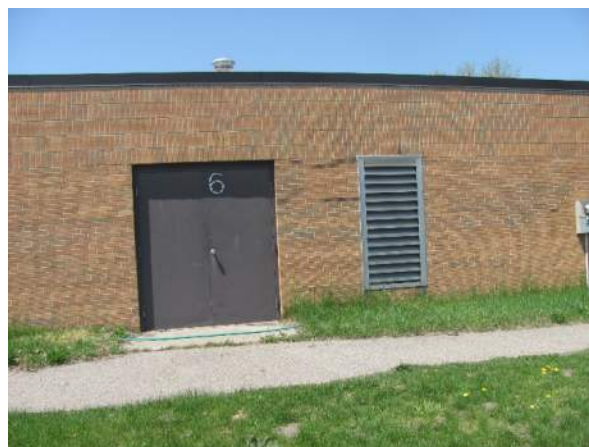
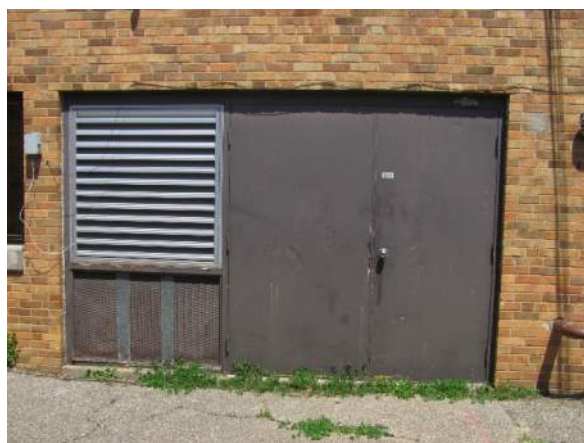
Existing storefront entrances are all in excellent condition. No issues noted.

Existing HM doors/frames are in fair condition. Eventually HM doors/frames rust and should be replaced w/Alum/FRP doors/frames.

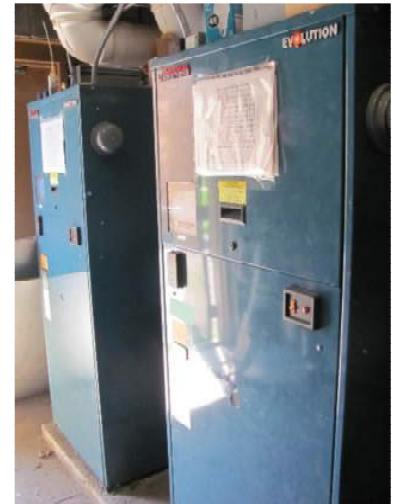
Boilers and associated pumps replaced in 2004. No work is required.

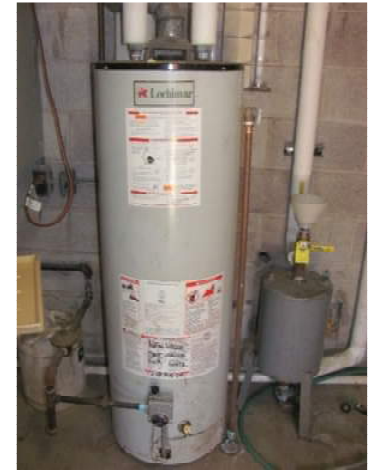
Domestic water heater includes a 40 gallon, 34 Mbh water heater in mechanical room serves portion building and is in fair condition. Water heater is 20+ years old and may need replacement in 0-5 years. Also includes a 100 gallon, 199 Mbh water heater in mechanical room serves portion of building and is in good condition. Water heater is 13 years old and may need replacement in 5-10 years.

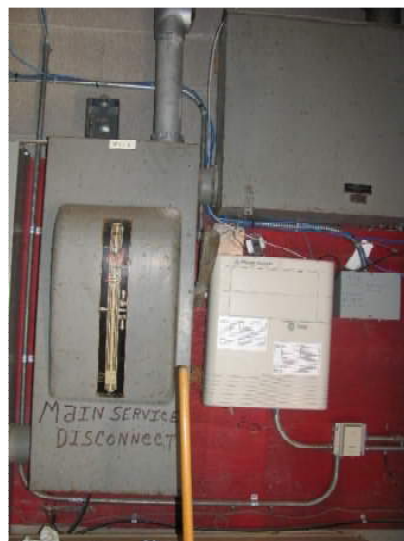
Replace original bulldog service switch

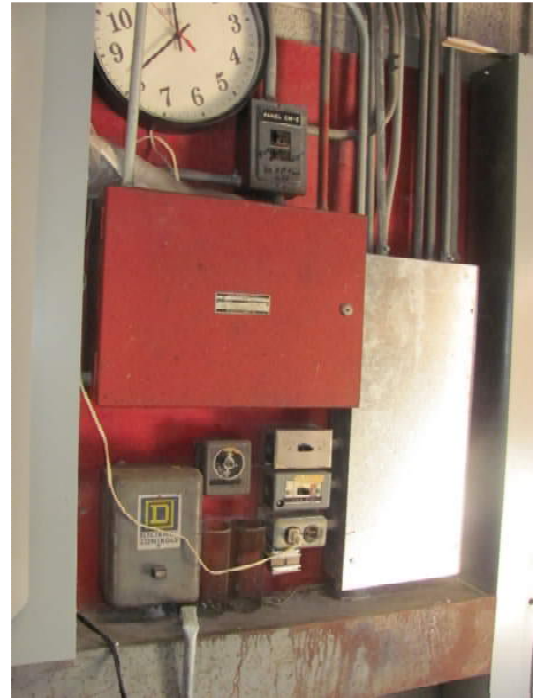
The original clock system is inadequate and recommended for replacement.

Public Address System – Replace

The program bell system – Replace

Sound systems – Replace.

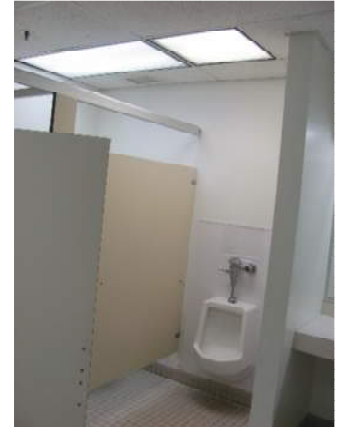
Functional remodeling may kick-in current building codes.

Recommend maintaining current use in current configuration.

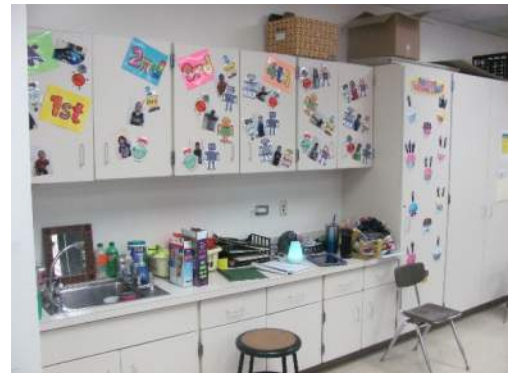
There are no known hazardous materials.

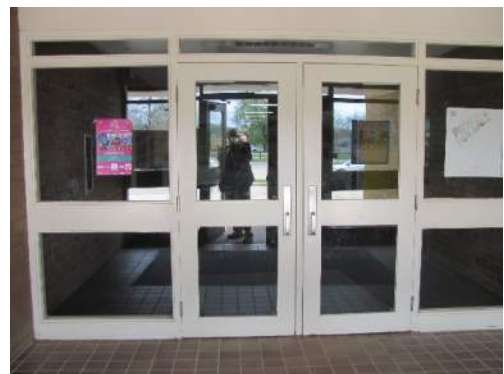
Building has secure entrance with electronic locks and recently installed camera system to control main entrance. The building has a web-based security camera system throughout building. There is not a secure vestibule into the main office. There does not appear to be door contacts to notify when exterior doors are compromised. Consider secure vestibule, security window film and door contacts in program improvements.

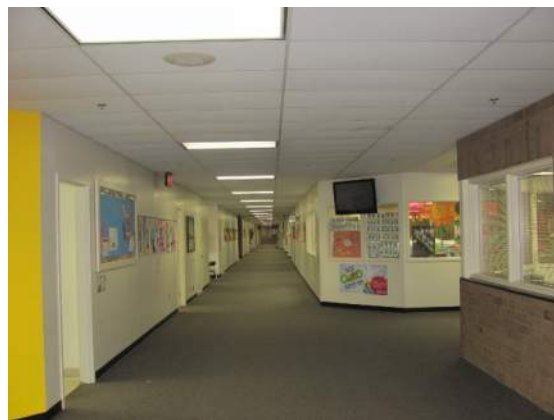
Corridor walls are mainly gypsum board and are very well maintained. Other than minor patching, no issues are noted. Classroom spaces are a combination of painted gypsum board and CMU and in good condition. No issues noted. Restroom walls are a combination of painted gypsum board and CMU and in good condition. No issues noted. Some will be updated in BF remodeling.

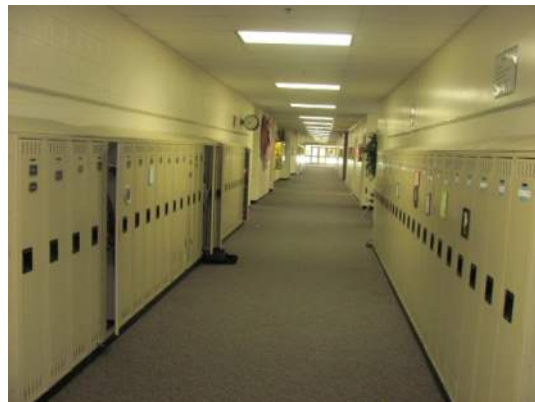
Ceilings are mainly suspended acoustical 2 x 4 panels in fair condition with some 'pillowing'. Gypsum board and exposed metal deck and are in good serviceable condition. No issues noted

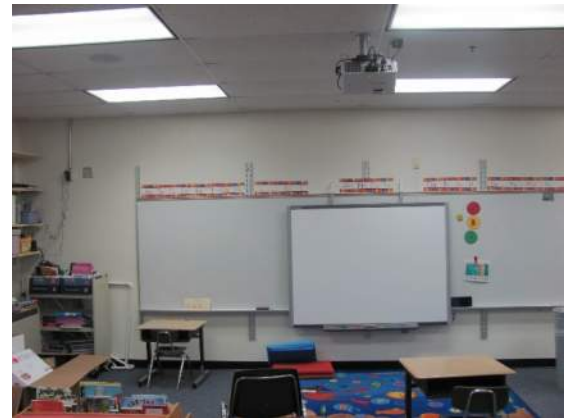
Majority of visual display boards (VDB) appear to be in good condition. No issues noted.

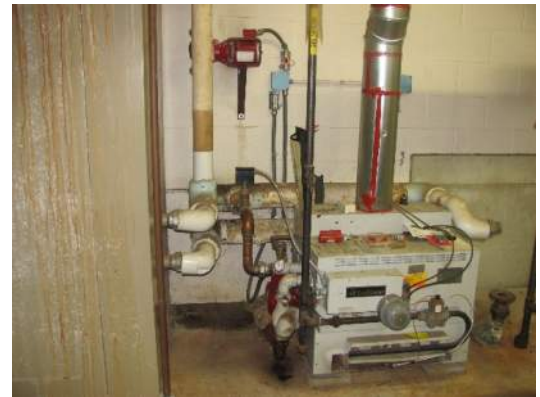
Domestic water heater is a 225 Mbh water heater with separate 500-gallon tank provides hot water for building and is in poor to fair condition. Water heater should be replaced in next 5 years.

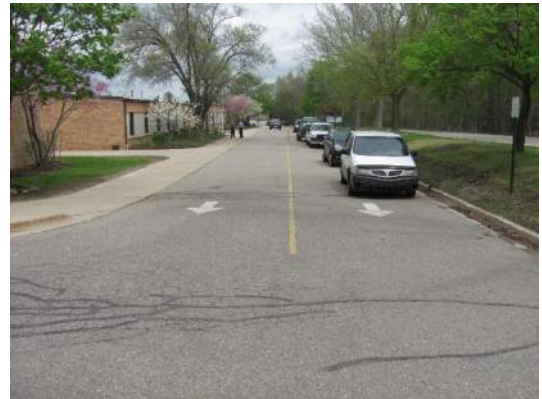
Main drive was repaved in 2003 and in fair to poor condition. Some cracks were observed. North lot repaved in 2005 and is in poor condition. Multiple cracks observed. Recommend repaving in next 5 years. Recommend repaving in next 5 years. South lot and 'Magic Square' hard surface play area were repaved in 2007. Magic Square is in fair condition. South lot is in fair to poor condition. Multiple cracks observed. Recommend repaving South lot in next 5- 10 years. Add new parking and parent pick-up/drop lanes west of north lot. Assume Road Commission will require deacceleration and by pass lanes. Site concrete in fair condition. Recommend allowance to reconstruct select concrete walks.

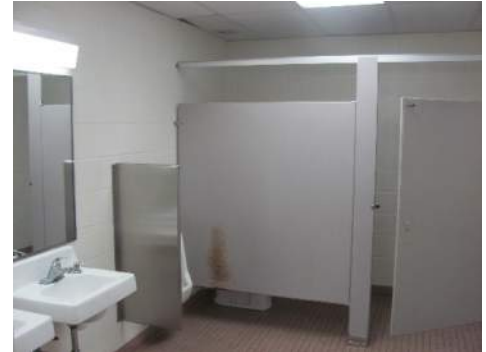
Built in 1955-57 and subsequent 1977, 1988 remodeling/additions, building meets barrier free codes in force during the latest remodeling (Grandfathered). Functional remodeling or an ADA challenge may require upgrades as follows:

- Replace select door hardware with BF lever (nic CRs)
- Remodel classroom 'pocket' entrances in 1955 CRs to meet BF
- Remodel select Toilet Rooms to meet BF.
- Add BF counters in classrooms

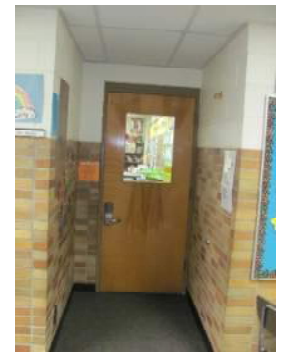
There appears to be some vinyl asbestos tile that should be abated. Unaware of other potential asbestos such as plaster or pipe insulation. Recommend an allowance for abatement.

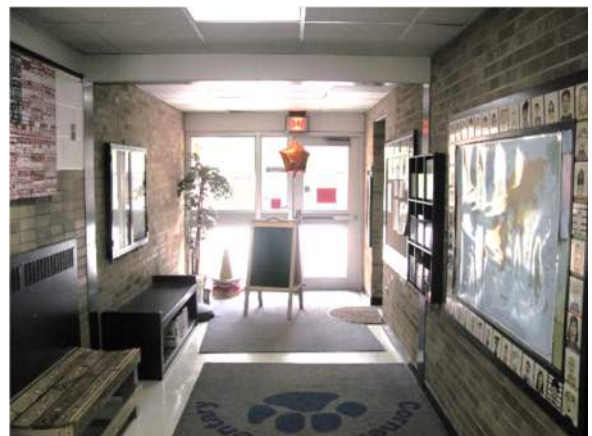
Building has secure entrance with electronic locks and recently installed camera system to control main entrance. The building has a web-based security camera system throughout building. There is not a secure vestibule into the main office. There does not appear to be door contacts to notify when exterior doors are compromised. Consider secure vestibule, security window film and door contacts in program improvements.

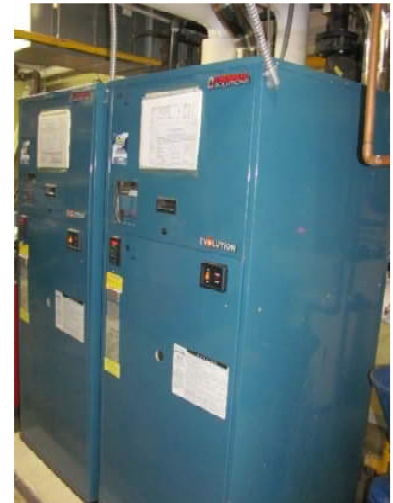
Boilers and associated pumps replaced in 2003. No work is required.

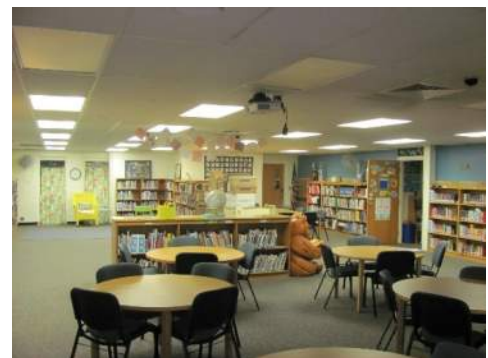
Recommend replacing original panelboards remaining in building. Replace original bulldog service panel.

Existing building has T-8 fluorescent lighting installed. Energy savings and better light quality would be realized with new LED lighting. Recommend converting lighting to LED. Presently there is no automatic lighting control within the building. Energy savings would be realized by adding occupancy sensors and automatic lighting control.

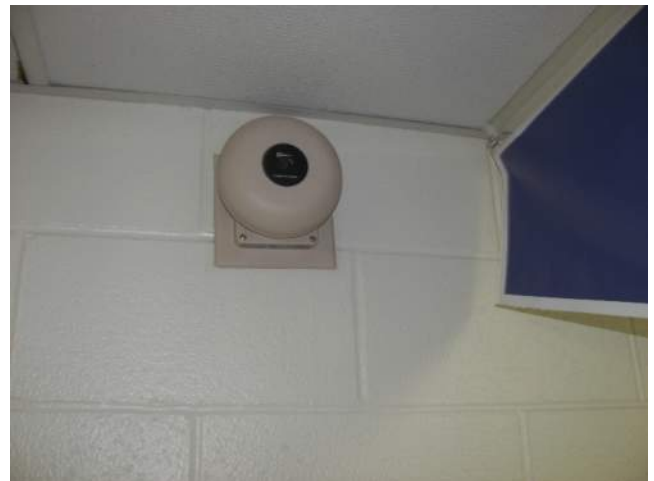
Replace existing exit signs.

Provide code compliant fire alarm system and new audio and visual devices.

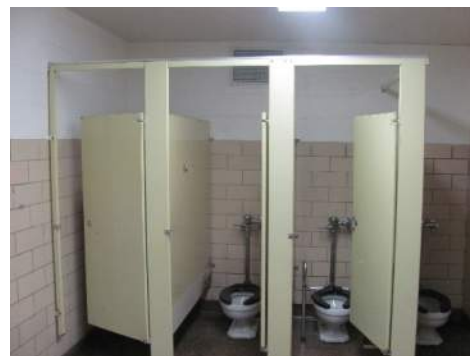
Built in 1948 and subsequent remodeling, building meets barrier free codes in force during the latest remodeling (Grandfathered). Functional remodeling or an ADA challenge may require upgrades as follows:

- Replace select door hardware with BF lever (nic CRs)
- Remodel classroom 'pocket' entrances to meet BF
- Remodel and addition to Toilet Rooms to meet BF (addition required to meet fixture count)
- Add BF counters in classrooms

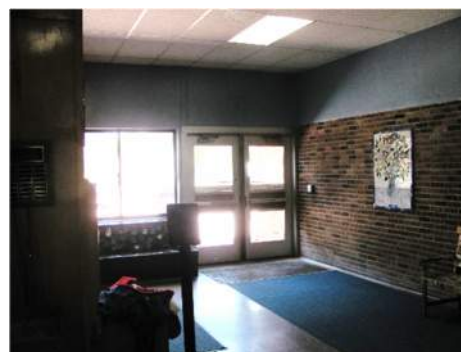
Building has secure entrance with electronic locks and recently installed camera system to control main entrance. The building has a web-based security camera system throughout building. There is not a secure vestibule into the main office. There does not appear to be door contacts to notify when exterior doors are compromised. Consider secure vestibule, security window film and door contacts in program improvements.

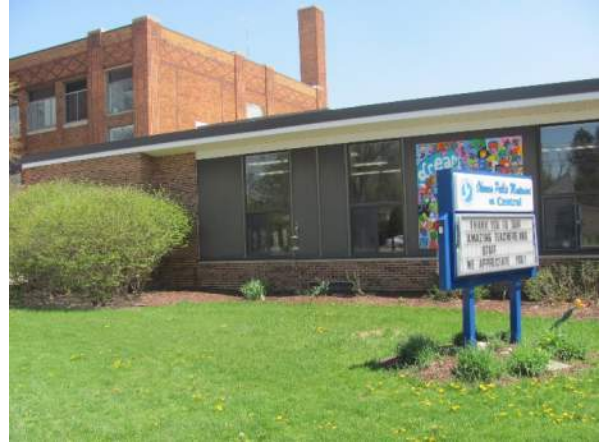
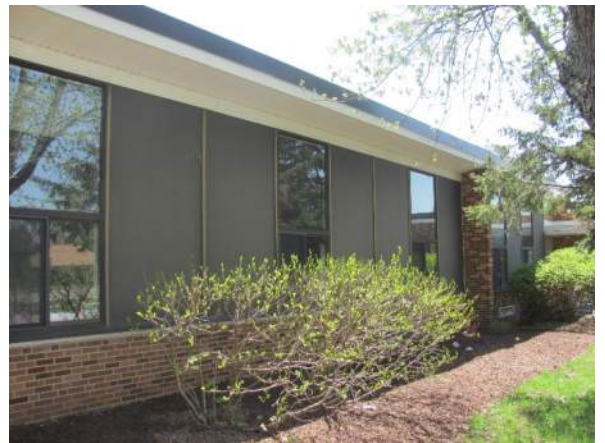
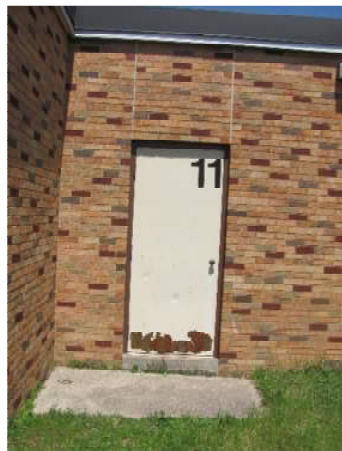
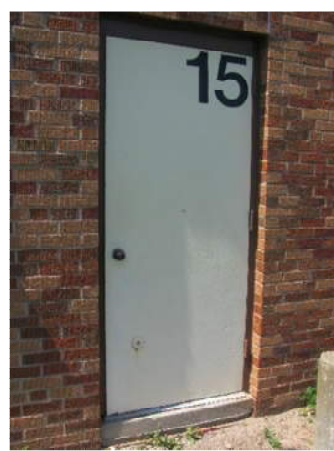
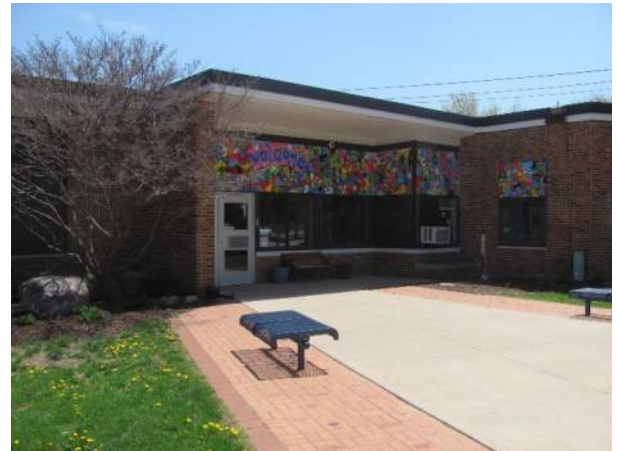
Cooley PVC roof installed in 2002 and 2008 (includes Central Administration). Cooley out of business and roof out of warranty. Replace in next 5 years.

Existing modular brick envelope appears to be in good condition with no reported problems. Wood fascia on southeast wing is deteriorating. Replace with Metal siding.

Window systems appear to have been replaced in the late 1970s/early 1980s with a great majority of the openings covered with panels, presumably to save energy. Recommend replacing full openings with insulated, thermally broke aluminum frames and insulated glazing and insulated translucent panels. These will allow daylight harvesting, increased fresh air openings and energy efficiency.

Existing storefront entrances are all in excellent condition. No issues noted.

Existing HM doors/frames are in fair condition. Eventually HM doors/frames rust and should be replaced w/Alum/FRP doors/frames.

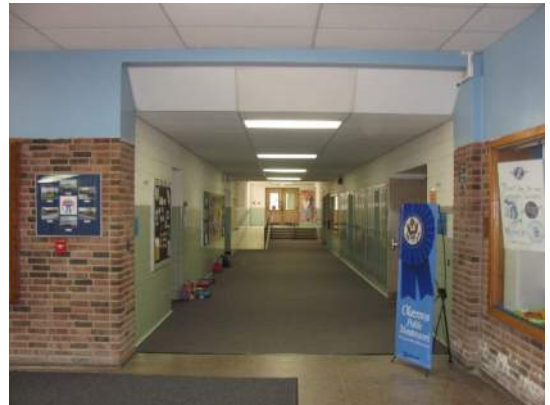
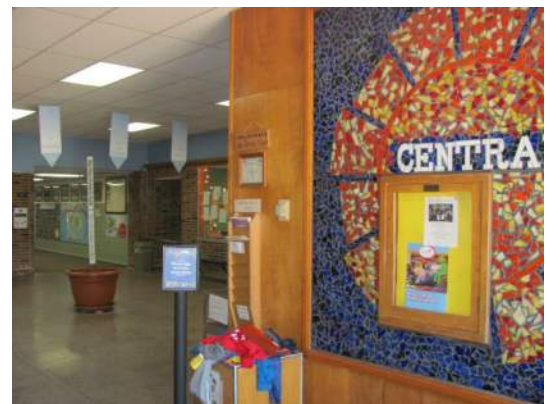
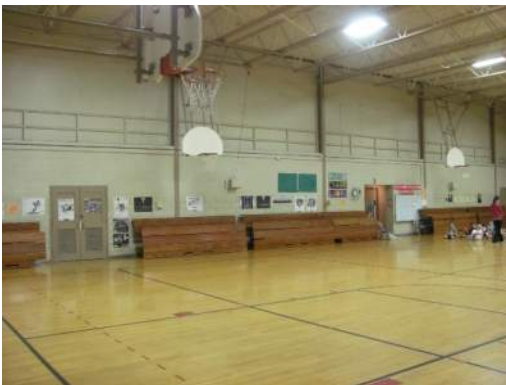
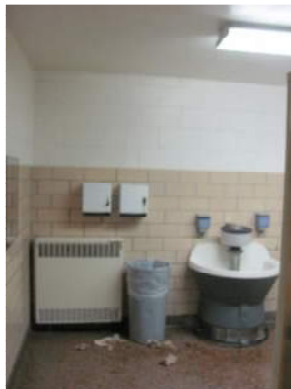
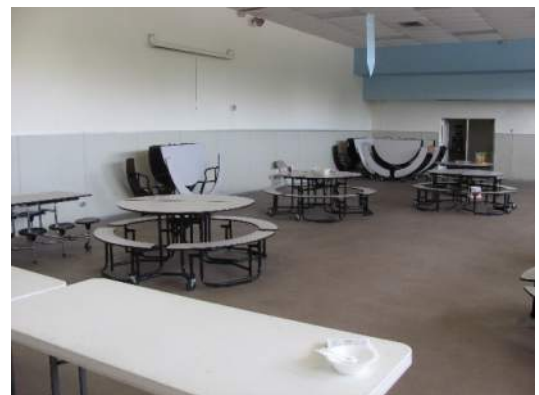
**Flooring** is a mix of carpet, vinyl composition and asbestos tile (VCT & VAT), wood sports flooring, terrazzo, quarry tile and ceramic mosaic tile and with the exception of carpet, in good condition. Most carpet is worn and nearing the end of its serviceable life. The district has done a good job of selectively replacing carpet throughout all buildings through their sinking fund.

Replace VCT/VAT flooring in select areas.

Wood sports flooring in Gym is in good condition.

VCT in vestibules is in fair condition, but often covered with throw rugs. Recommend replacement with special recessed entrance 'walk-off' carpet mats

Sheet flooring in cafeteria is in poor condition and should be replaced.

While dated in appearance, tile/terrazzo in toilet rooms and Kitchen is in fair condition. Replace within toilet room remodeling budget.

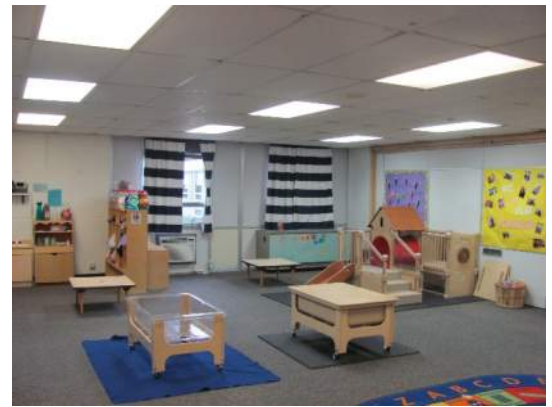
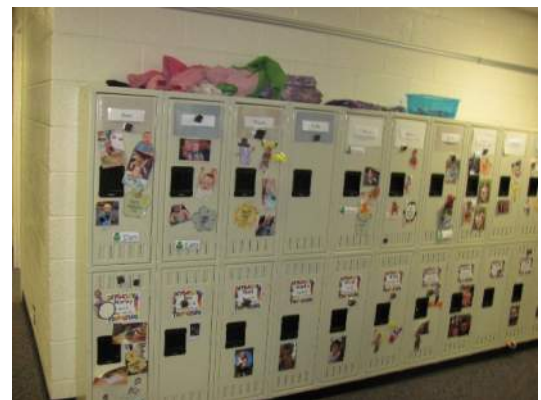
Corridor walls are a combination of brick, block and glazed tile and while 'dated' in color, are very durable. Other than low reflectivity, no issues are noted.

Classroom spaces are a combination of painted gypsum board and CMU and in good condition. With the removal of existing chalkboards and replacement with new, walls damaged from removal will require patching, repair and finishing.

Restroom walls are generally glazed tile/painted gypsum board/CMU and in fair to poor condition. These will be updated in BF remodeling.

Acoustical 2 x 4 panel ceilings and grid are in fair condition. Some are sagging from moisture. Consider replacing in the future with 2 x 2 grid and panels.

Existing interior wood door/frames are in poor condition. Recommend replacement with new HM frames/wood doors. District installed electronic access locks at all classrooms. Reuse in new doors. Note 10 'pocket' entrance doors included above in BF item.

Corridor Lockers are in fair/poor condition. Some rust occurs in bottoms and some doors are out of alignment. Recommend replacement with new.

Majority of classroom storage cabinets are the original built-in wood and are in poor condition. Replace with new laminate clad casework. Assume 20 rooms with an average of 24 LF of uppers and lowers. Unit price includes demolition and wall remodeling to accommodate new casework.

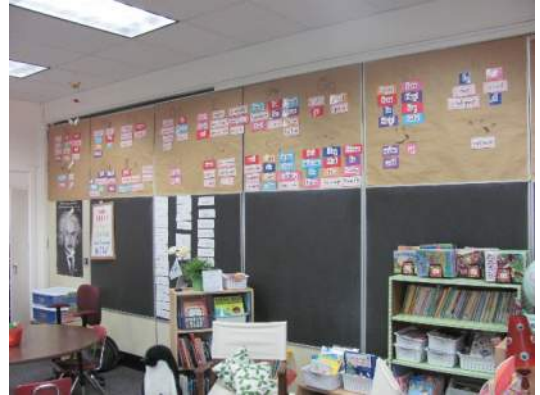
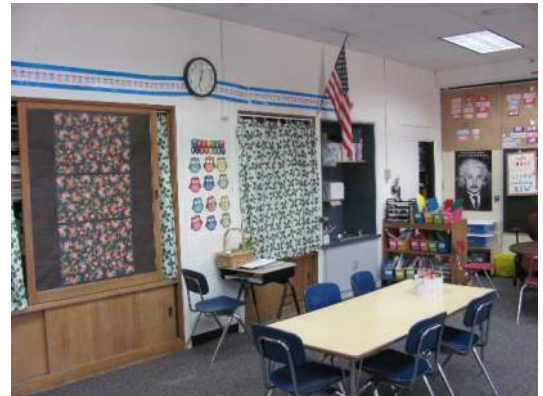
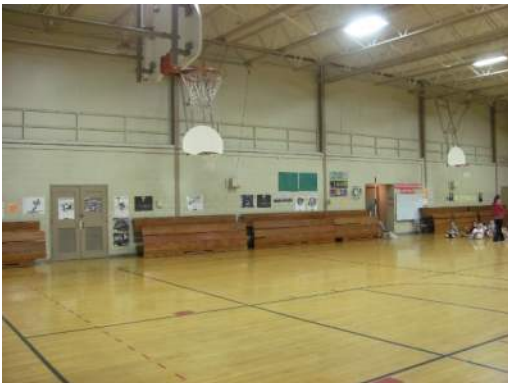
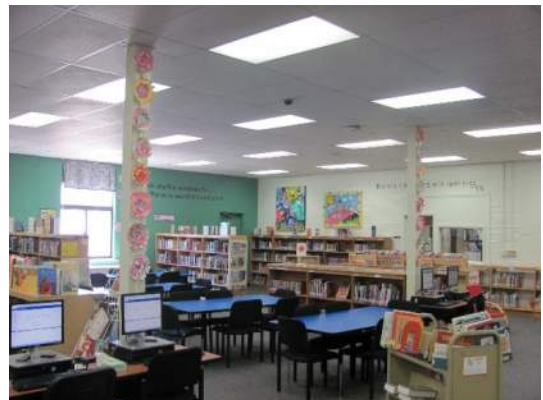
Recommend new blinds integral with proposed new windows above.

Replace sills with new windows.

Recommend adding acoustical panels to mitigate noise in Gym and Cafeteria.

Majority of visual display boards (VDB) are chalkboards. Recommend removing existing and replacing with porcelain enamel markerboards and tackboards.

Display cases in existing corridors are original wood and should be replaced with new aluminum/glass units that meet corridor fire safety rules.

Replace existing fixed basketball goals with new adjustable units for elementary students.

Remove existing wood bleachers - in poor condition.

Some classroom furnishings are old and educationally inflexible. In order to encourage collaboration and 21st century pedagogies replacement furnishings should be lightweight, stackable, ergonomically appropriate to facilitate learning. Media centers should be designed with comfortable project, study and reading areas wired for current technologies.

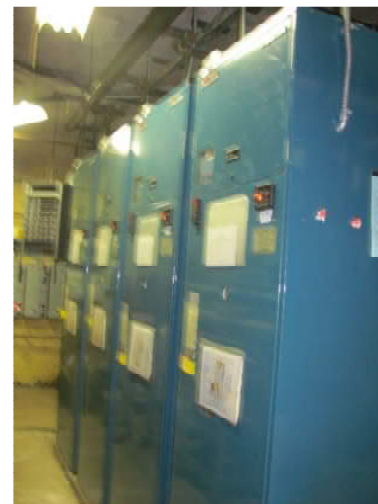
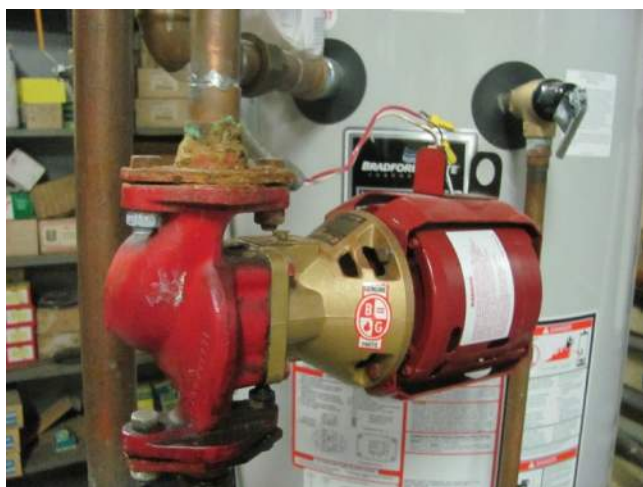
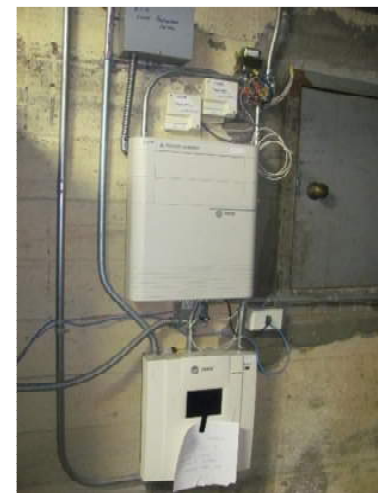
In general, the existing mechanical systems have been very well maintained through wise sinking fund investments and are in good condition. Continue normal maintenance procedures to maximize life cycle.

Boilers and associated pumps replaced in 20032. No work is required.

Recommend replacing (heating only) classroom unit ventilators.

Exhaust systems are original to building and should be replaced.

Replace existing pneumatic temperature controls with new DDC system to communicate with district's system. Update existing energy management system (Trane). Replace CO2 sensors.

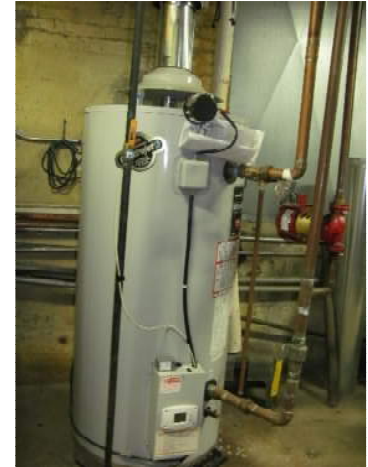
Provide new gas line from Central Elementary, through tunnel, to Print Shop to replace broken line and eliminate propane tank.

Majority of piping is original to building and has a life expectancy of 80 years. Past water quality events in Flint have led to concerns about the water quality in all schools across Michigan. Aging facilities with old piping and water service sources may lead to future legislation requiring potential costly piping and fixture replacement. Until testing has been completed at each school facility, it is difficult to predict the cost impact or where funding will come from. as such a budget for testing is included in this assessment for each school building.

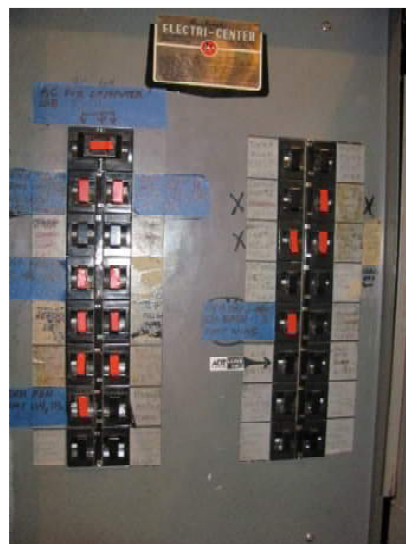
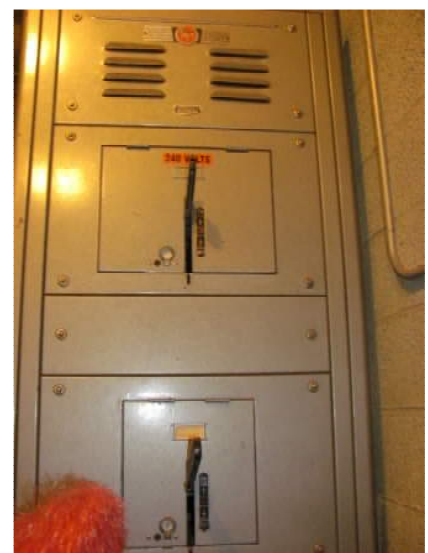
Recommend replacing all electrical distribution in building including fusible panelboards in corridors accessible to children.

Provide tamper proof receptacles in areas required by NEC 406.12

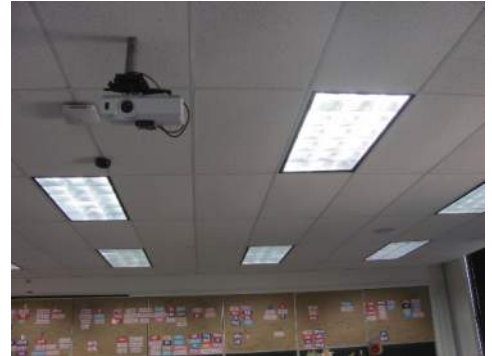
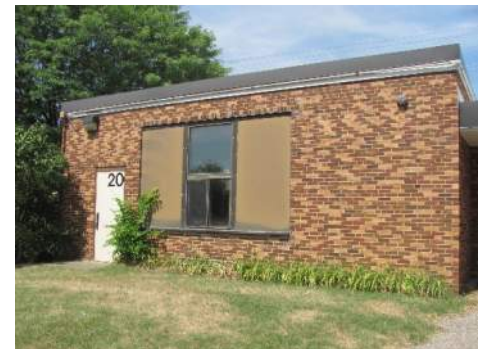
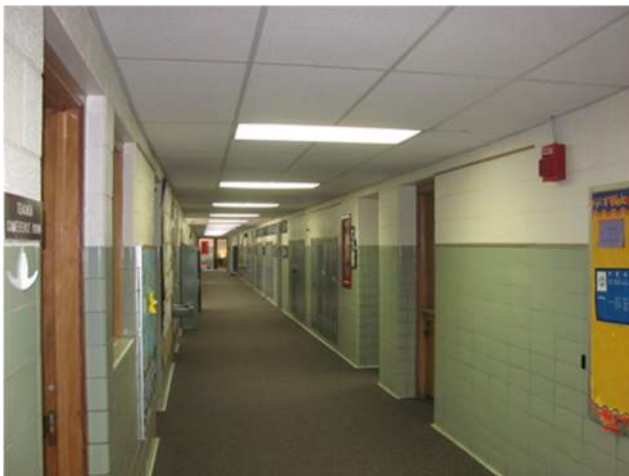
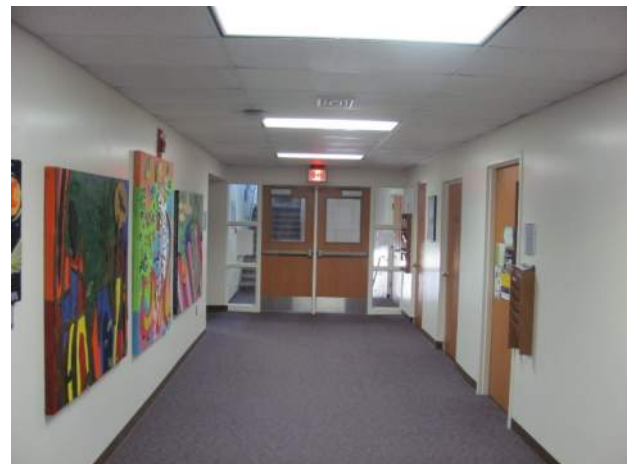
Existing building has T-8 fluorescent lighting installed. Energy savings and better light quality would be realized with new LED lighting. Recommend converting lighting to LED. Presently there is no automatic lighting control within the building. Energy savings would be realized by adding occupancy sensors and automatic lighting control.

Similarly recommend replacing existing site lights with new LED site lighting and poles as well as replacing existing building HID fixtures with LED fixtures.

Replace existing exit signs.

Provide code compliant fire alarm system.

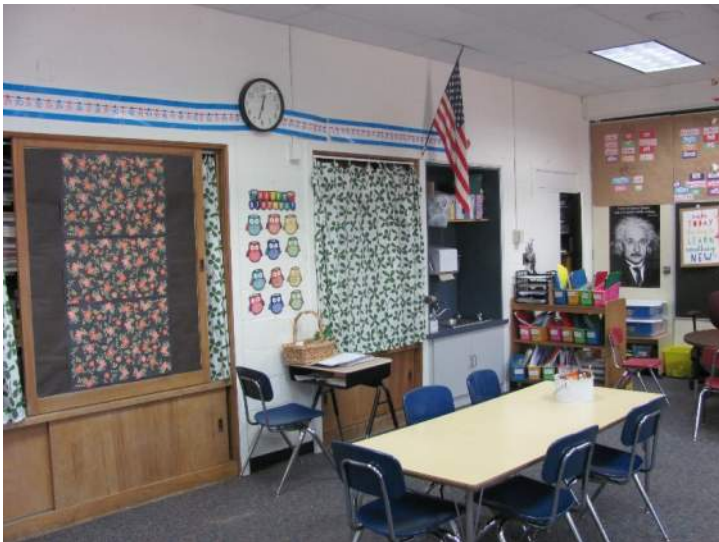
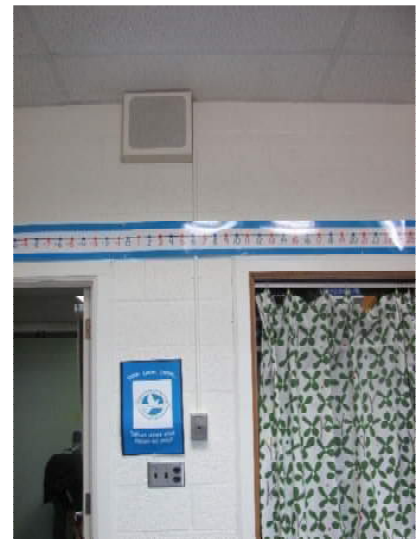
Public Address System – Recommend replacing.

The program bell system – Recommend replacing

The original clock system is inadequate and recommended for replacement.

Sound systems – no issues noted.

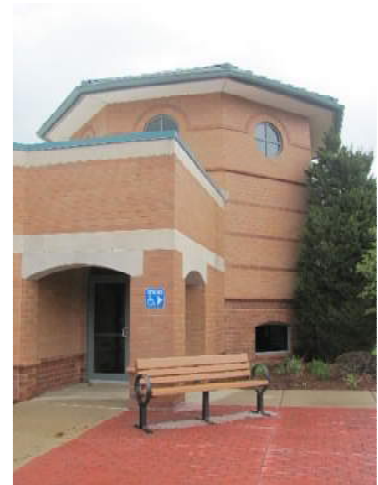
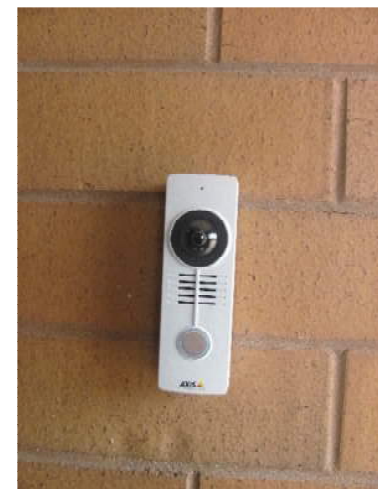
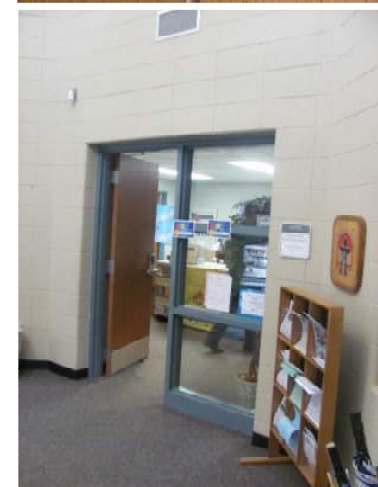
Existing masonry chiller screen wall is deteriorating. Recommend removal and replacement.

Drives and lots repaved in 2013 and in excellent condition. With proper maintenance lots should be serviceable for another 10 - 15 years. Site concrete in fair condition. Recommend allowance to reconstruct select concrete walks. Brick pavers at entrance are deteriorating. Could be a potential trip hazard. Recommend replacing with stamped, colored concrete.

Playground equipment is in fair condition. Structures replaced in 2002. Some replacement may be required. District maintains and adds surfacing yearly. Provide allowance for new playground structures. Existing masonry playground wall is deteriorating. Recommend removal and replacement with decorative steel fence.

Building has secure entrance with electronic locks and recently installed camera system to control main entrance. The building has a web-based security camera system throughout building. There is not a secure vestibule into the main office. There does not appear to be door contacts to notify when exterior doors are compromised. Consider secure vestibule, security window film and door contacts in program improvements.

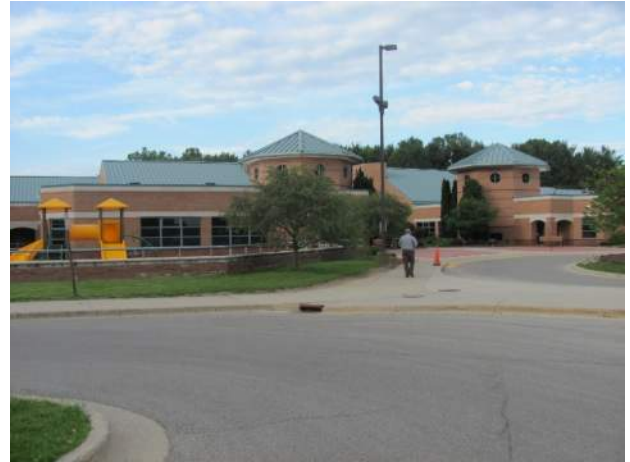
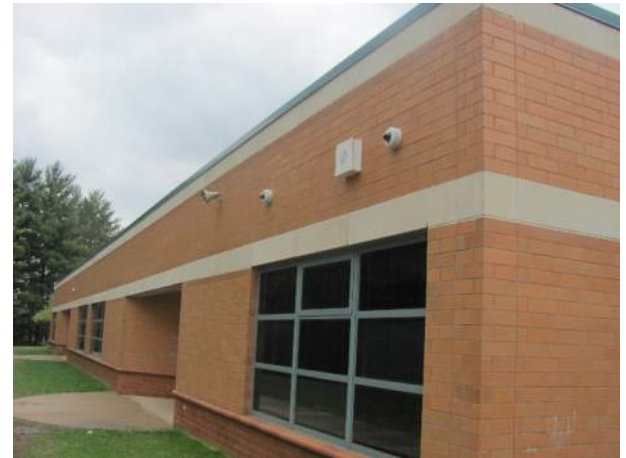
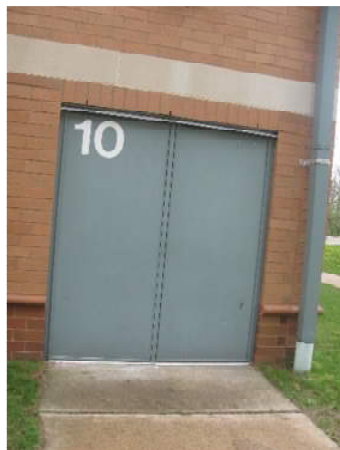
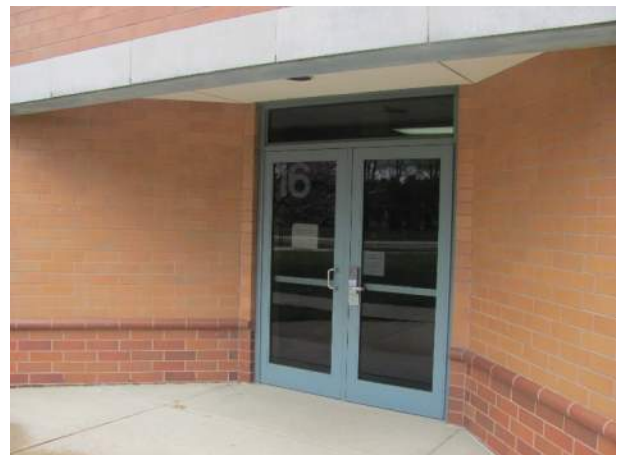
Royal West/Firestone PVC roof over west wing was replaced in 2008 and if well maintained, should be serviceable until 2025 - 2028.

Metal roof, gutters, downspouts over are in excellent condition. No issues noted.

Jumbo brick with cast stone bands envelope in excellent condition. No issues noted.

Original colored aluminum insulated windows with integral blinds are in excellent condition. No issues noted. Existing storefront entrances are all in excellent condition. No issues noted.

Existing HM doors/frames are in fair condition. Eventually HM doors/frames rust and should be replaced w/Alum/FRP doors/frames.
