# Okemos Public Schools

Facilities Assessment

September 2018

# Kingscott

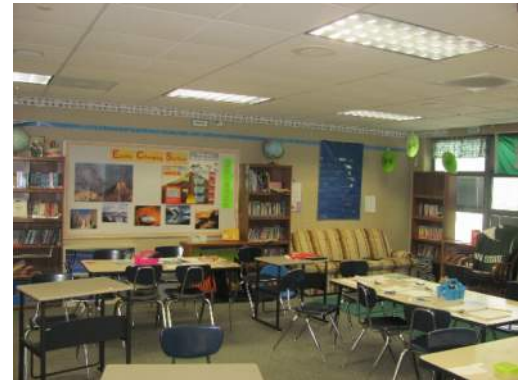
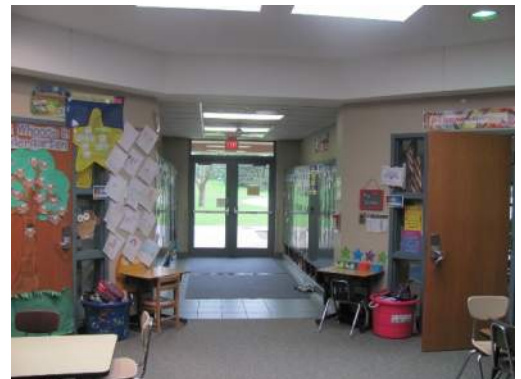
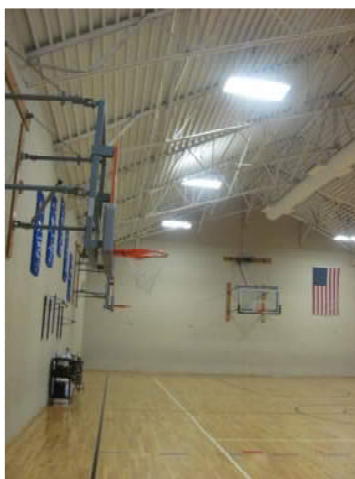
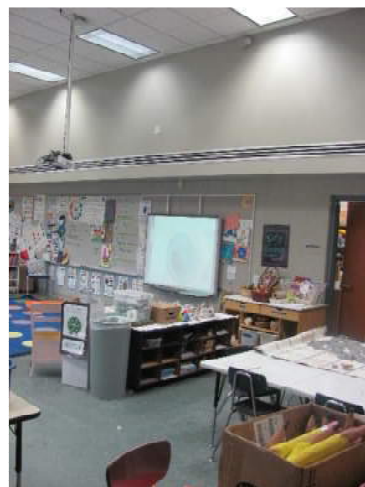
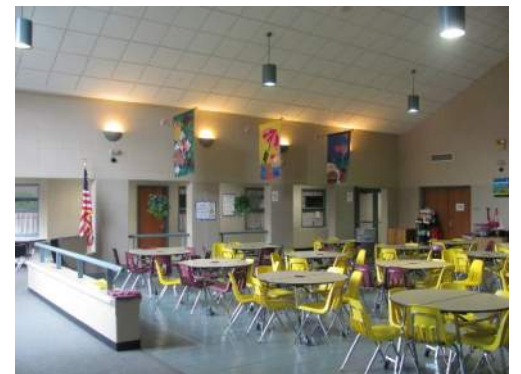
**Flooring** is a mix of carpet, vinyl composition tile (VCT), wood sports flooring, porcelain, quarry and ceramic mosaic tile all mainly in good condition. Carpet in corridors and select classrooms is worn and nearing the end of its serviceable life. The district has done a good job of selectively replacing carpet throughout all buildings through their sinking fund.

Wood sports flooring in Gym is in good condition.

Porcelain tile in vestibules is in excellent condition, but often covered with throw rugs. Recommend replacement with special recessed entrance 'walk-off' carpet mats.

Replace sheet flooring in Art Room. Consider polished concrete.

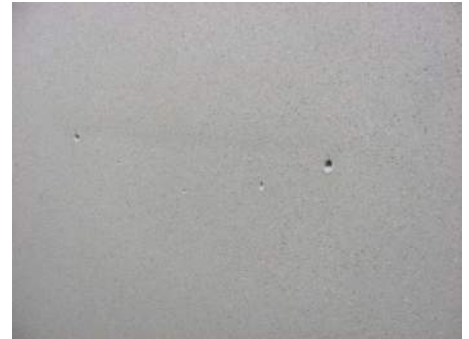
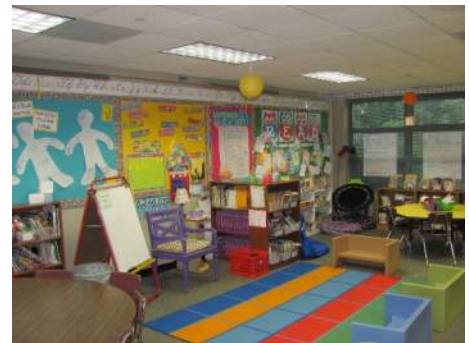
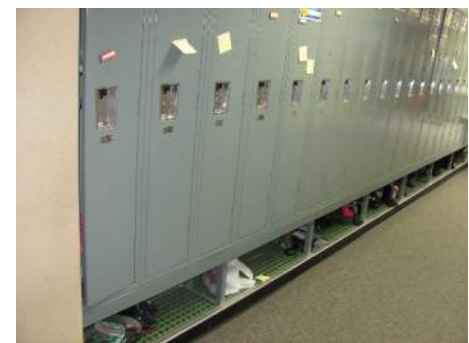
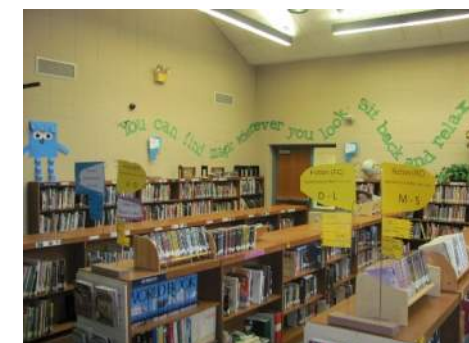
Interior classroom walls are a combination of painted gypsum board and CMU and in good condition. With continuing good maintenance, these shall serve well into the future.

Majority of public space walls are a durable 'Zolotone' paint system finish in fair to good condition. Surfaces that are damaged are not 'patchable' with this system. Recommend replacing surfaces with semi-gloss enamel coatings.

Majority of laminate clad casework is in good condition with the exception of some oversized doors and some countertop delamination in places. Recommend replacement allowance in 5 years and in 5 - 10 years.

Replace existing fixed basketball goals with new adjustable units for elementary students.

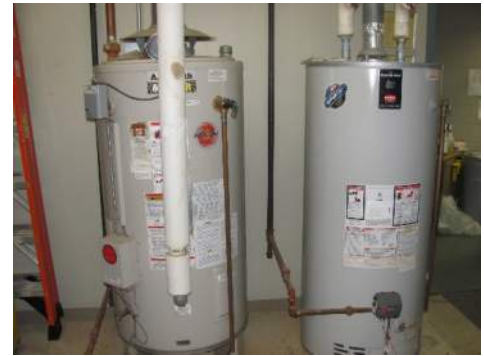
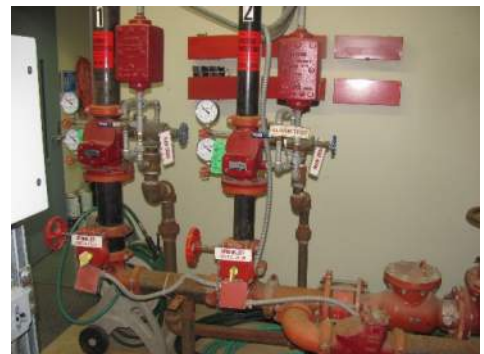
Majority of piping is original to building and has a life expectancy of 80 years. Past water quality events in Flint have led to concerns about the water quality in all schools across Michigan. Aging facilities with old piping and water service sources may lead to future legislation requiring potential costly piping and fixture replacement. Until testing has been completed at each school facility, it is difficult to predict the cost impact or where funding will come from. as such a budget for testing is included in this assessment for each school building.

Domestic water heaters are a 75 gallon, 76 Mbh and 80 gallon, 190 Mbh, serving building well and in good condition. Water heaters are 15+ years old and may need replacement in 5-10 years.

A 6-inch fire suppression main with two 4-inch risers provide fire suppression for entire building.

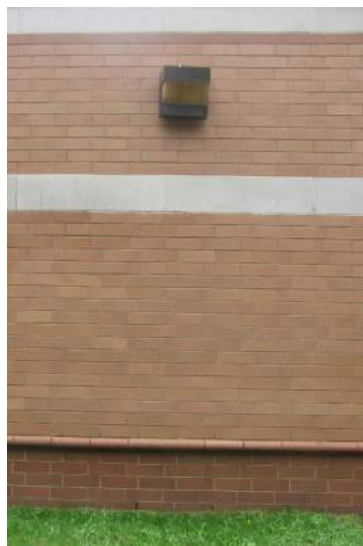
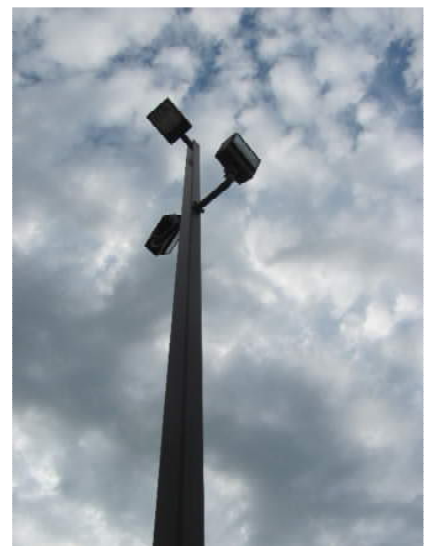
Panels and distribution in good condition. No issues noted.

Recommend replacing existing site lights with new LED site lighting on existing poles.

Recommend replacing existing HID fixtures with new LED fixtures.

Provide tamper proof receptacles in areas required by NEC 406.12

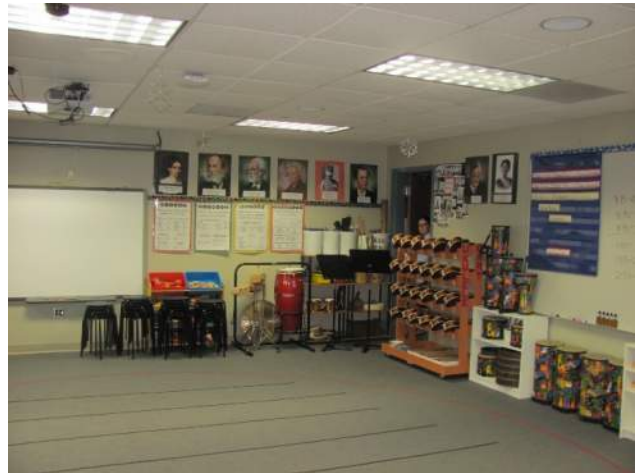
Existing building has T-8 fluorescent lighting installed. Energy savings and better light quality would be realized with new LED lighting. Recommend converting lighting to LED. Presently there is no automatic lighting control within the building. Energy savings would be realized by adding occupancy sensors and automatic lighting control.

Consider adding a generator to handle boilers and designated essential items.

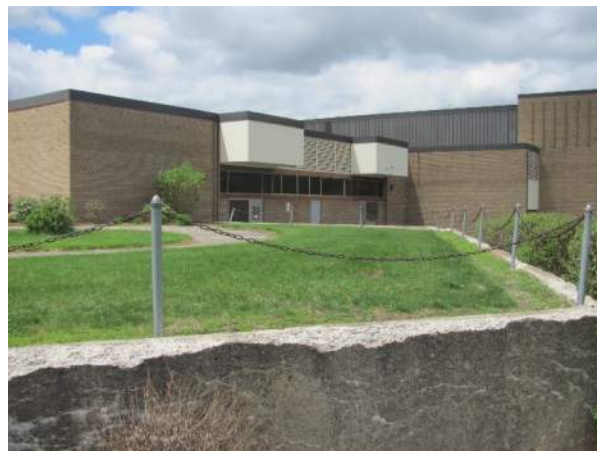
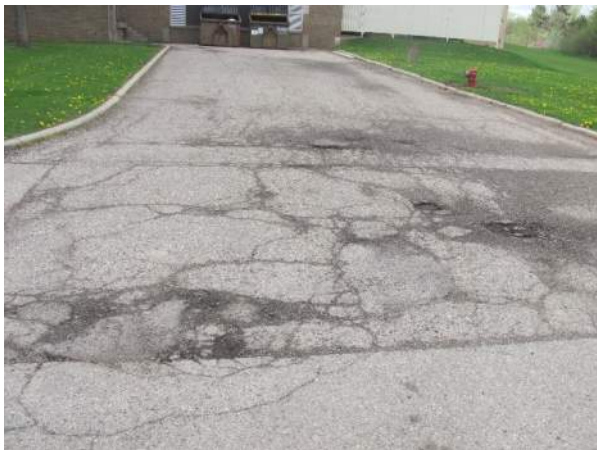
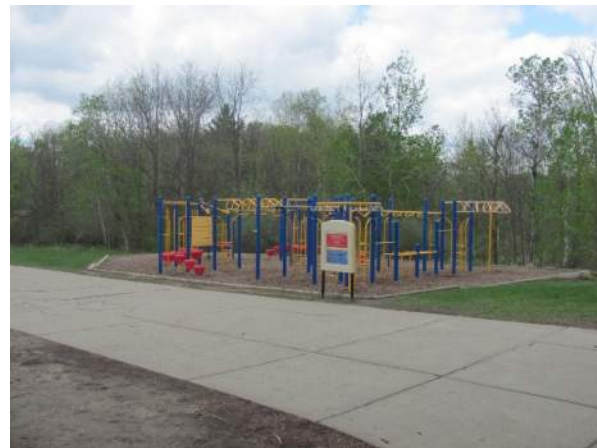
Site appears to be well drained. Landscape is well maintained. Site retaining wall on southeast is deteriorating. Remove, regrade and re-seed.

Existing masonry chiller screen wall is deteriorating. Recommend removal and replacement.

Main lot on east and drives received new base and asphalt in 2004 in fair condition. Exhibiting cracks and wear especially in the drive. Recommend repaving. Asphalt walks off east lot in poor condition. Exhibiting cracks and wear. Recommend repaving w/concrete. Asphalt hard play area in poor condition. Exhibiting cracks and alleagatoring. Recommend repaving.

Playground equipment is in fair condition. Some replacement may be required. District maintains and adds surfacing yearly. Provide allowance for new playground structures. Existing masonry playground wall is deteriorating. Recommend removal and replacement with decorative steel fence.

Tennis courts w/fencing in fair condition. Resurfaced in 2008. Rebuild with concrete base and surfacing in 5 - 10 years

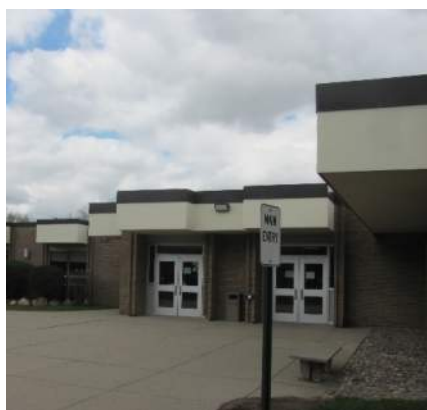
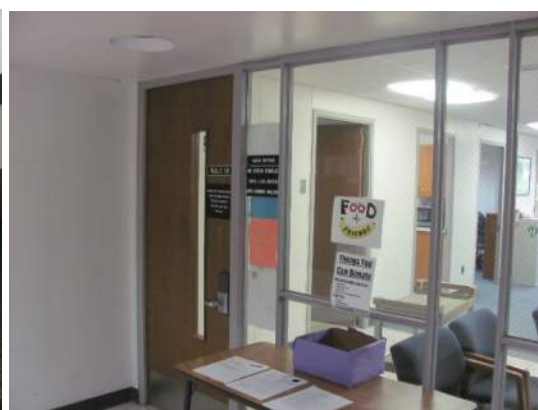
Building has secure entrance with electronic locks and recently installed camera system to control main entrance. The building has a web-based security camera system throughout building. There is not a secure vestibule into the main office. There does not appear to be door contacts to notify when exterior doors are compromised. Consider secure vestibule, security window film and door contacts in program improvements.

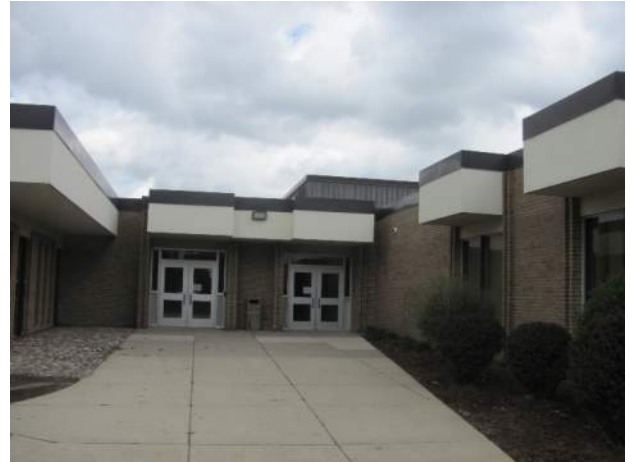
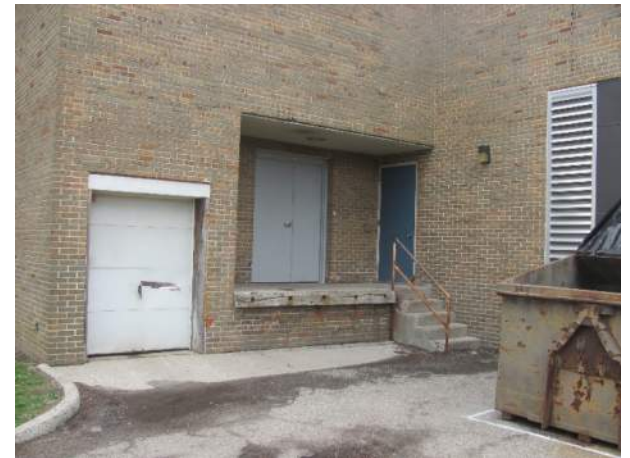
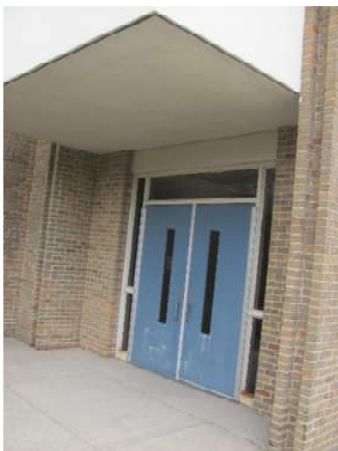
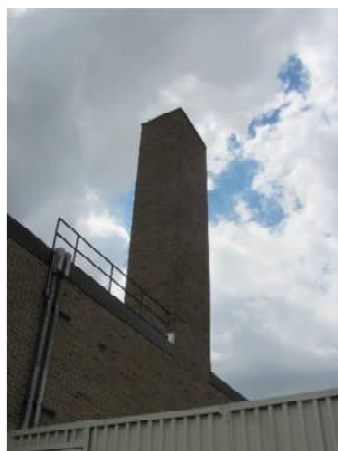
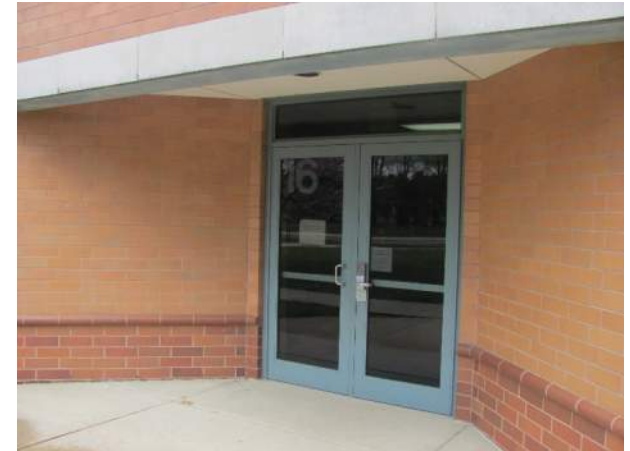
S & B Firestone PVC roof over west and north classroom wings were replaced in 2001 and reaching the end of their serviceable life. Recommend replacement in next 1 - 5 years. Cooley PVC roof over south classrooms and cafeteria were replaced in 2003 in and reaching the end of their serviceable life. Recommend replacement in next 1 - 5 years. McDonald Carlisle PVC roof over auditorium, pool gym were replaced in 2011 in and if well maintained should be serviceable until 2027.

Brick envelope in excellent condition. No issues noted. Original brick chimney is in poor condition and not necessary anymore. Remove and cap. Plaster soffits/fascia overhangs in good condition. No issues noted. Loading dock is in poor condition. Rebuild.

Original single glazed aluminum windows are in fair to poor condition. Recommend replacing with insulated glazing w/integral blinds.

Existing HM doors/frames are in fair condition. Eventually HM doors/frames rust and should be replaced w/Alum/FRP doors/frames.

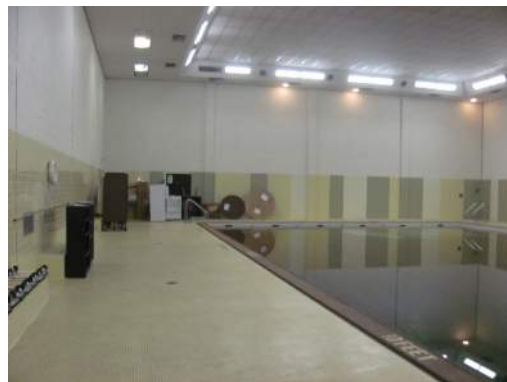
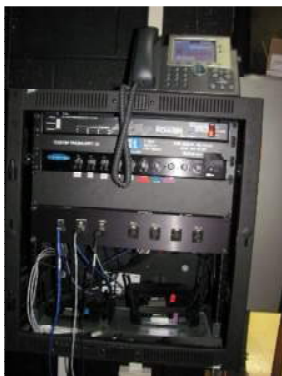
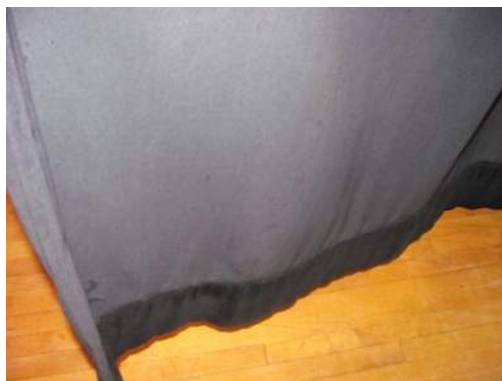
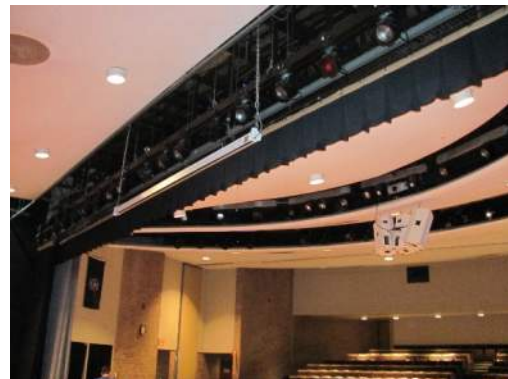
Facility in excellent condition. With the exception of closing or repurposing the pool/lockers and remodeling the auditorium, no general remodeling necessary from cyclical maintenance.

Existing pool is currently closed. Consider upgrades necessary to reopen pool as physical education learning space or redevelop for project-based learning/STEAM space or other function.

Recommend upgrading Auditorium systems including stage lighting, drapery, sound/AV and stage flooring.

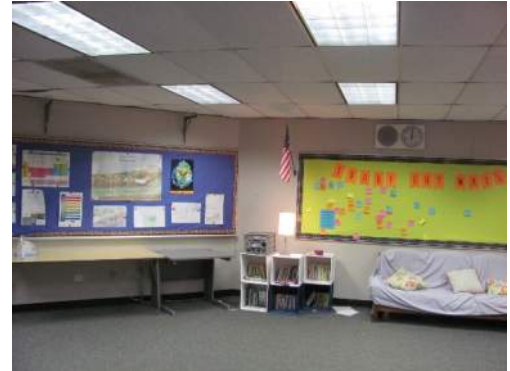
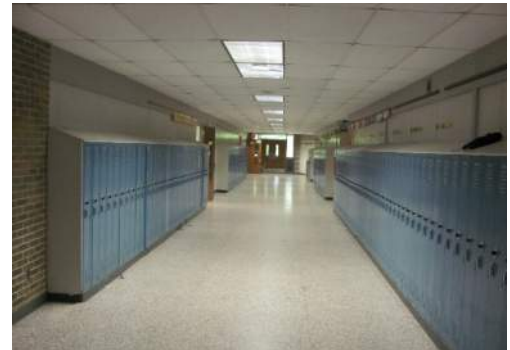
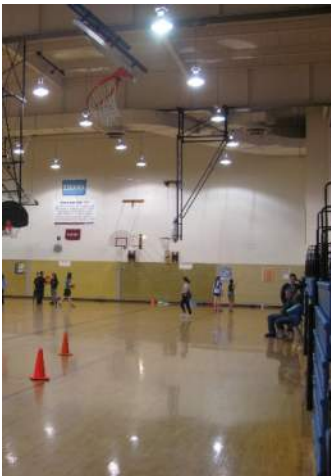
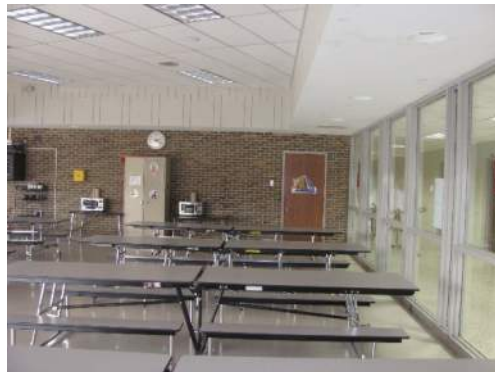
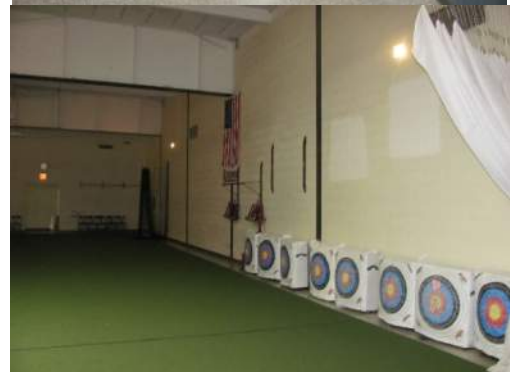
**Flooring** is a mix of terrazzo, carpet, vinyl composition (and some Asbestos) tile (VCT/VAT), wood sports flooring, quarry and ceramic mosaic tile all mainly in good condition. Carpet in select classrooms/areas is worn and nearing the end of its serviceable life. The district has done a good job of selectively replacing carpet throughout all buildings through their sinking fund.

Terrazzo and hard tile flooring in excellent condition. No issues noted.

Wood sports flooring in Main Gym is in good condition.

Replace flooring in Art Room. Consider polished concrete.

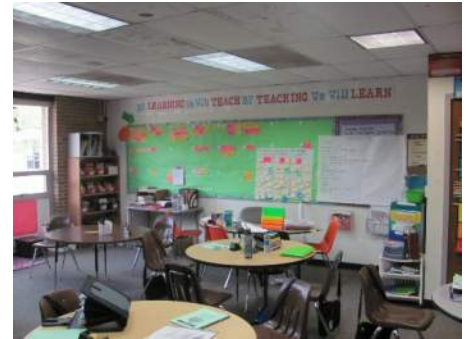
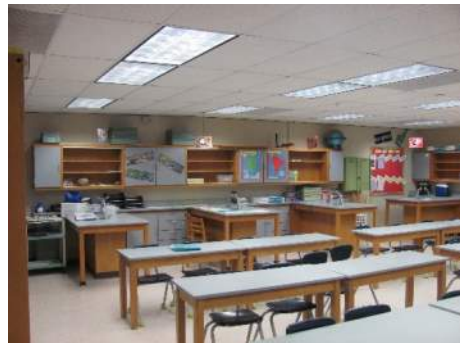
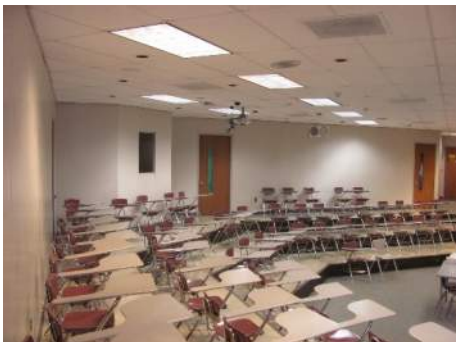
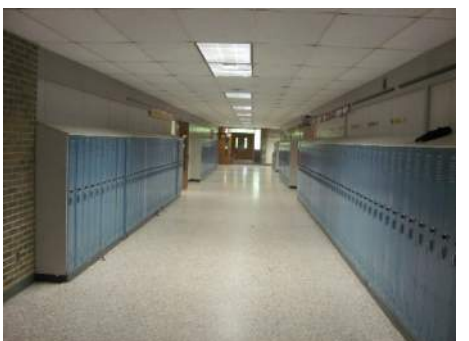
Existing walls in the classroom wings are demountable partitions, secured to the ceilings. This system does not prevent the transmission of noise between classrooms and corridors. Recommend removing and replacing with acoustically treated gypsum partitions to the deck. This will also require ceiling replacement.

Existing operable panel partitions are not in good working condition and are not used. Recommend removal and replacement with gypsum partitions

Acoustical panel ceilings and grid are in fair to good condition. Some panels are 'pillowed' from moisture, but still serviceable. Some gypsum board ceilings were observed to be damaged from water. Recommend replacement.

Corridor Lockers are in fair condition. Some rust will occur in bottoms and some doors are out of alignment. With good maintenance, lockers should be serviceable for next 5 -10 years. PE/Team lockers are in fair condition. Typically PE lockers are in a high abuse environment. Recommend replacing half in next 5 years and half in 5 - 10 years.

Majority of interior wood doors are in excellent condition. District installed electronic access locks at all classrooms. Recommend allowance to replace existing damaged interior wood doors.

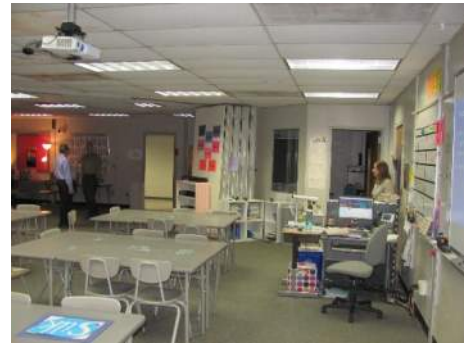
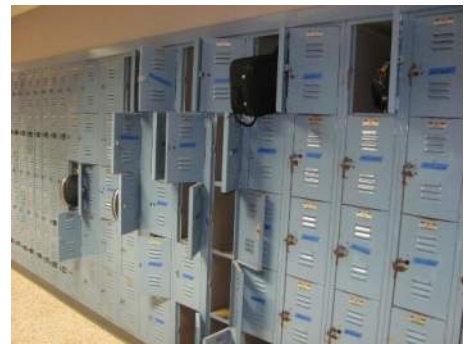
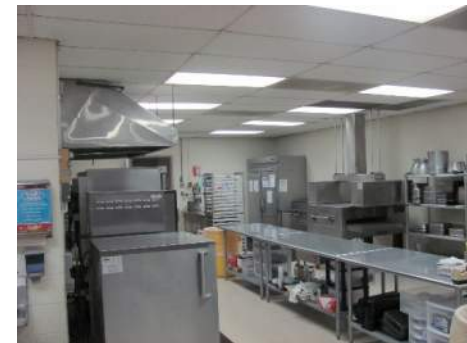
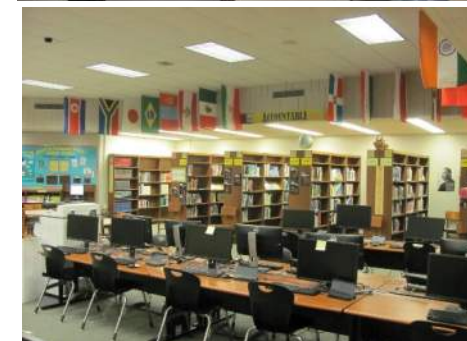
Majority of laminate clad casework is in good condition with the exception of some oversized doors and some countertop delamination in places. Recommend replacement allowance in 5 years and in 5 - 10 years.

Science room casework/tables/stations in fair condition. With good maintenance, they should be serviceable for the next 5+ years.

Music room/corridor instrument storage in fair to poor condition.

Some classroom furnishings are old and educationally inflexible. In order to encourage collaboration and 21st century pedagogies replacement furnishings should be lightweight, stackable, ergonomically appropriate to facilitate learning. Media centers should be designed with comfortable project, study and reading areas wired for current technologies.

Recommend replacement in 5 - 10 years

Recommend replacement in next 5 years.

Add a disposer to the three-compartment sink, a new 4 well hot food table, a new 5 well cold food table, two – 2 door refrigerators, re-equip the Ala-Carte area, Replace Hood & Fire System (to meet current MMC codes).

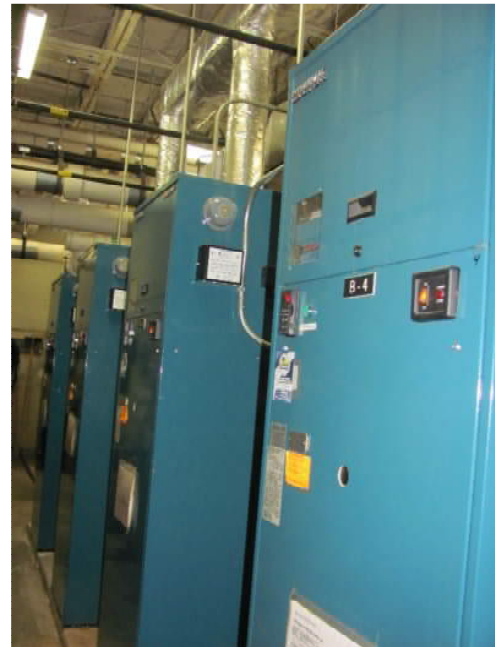
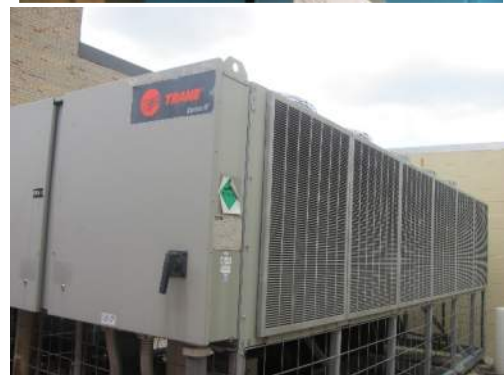
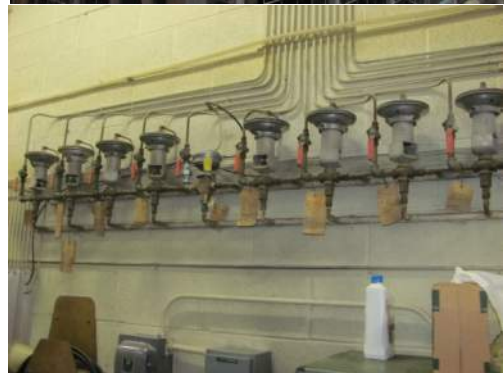
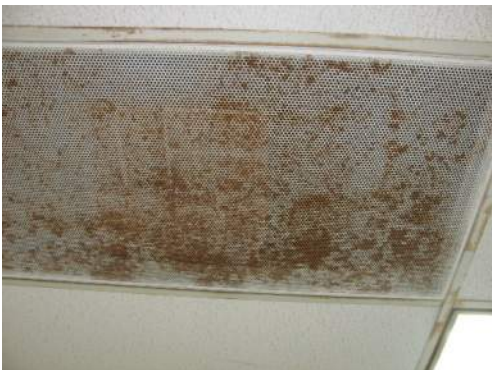
In general, the existing mechanical systems have been very well maintained through wise sinking fund investments and are in good condition. Continue normal maintenance procedures to maximize life cycle.

Boilers and associated pumps replaced in 2006. No work is required.

Two air-cooled chillers provide cooling for the building. Units are approximately 10 years old and in good condition.

Central air-handling units provide heating and cooling for the majority of the building. Units are in good condition.

Exhaust systems are original to building (40 years old) and should be replaced.

Replace rusting diffusers in 200 wing.

Replace existing pneumatic temperature controls with new DDC system to communicate with district's system.

Update existing energy management system (Trane). Add/replace CO2 sensors.

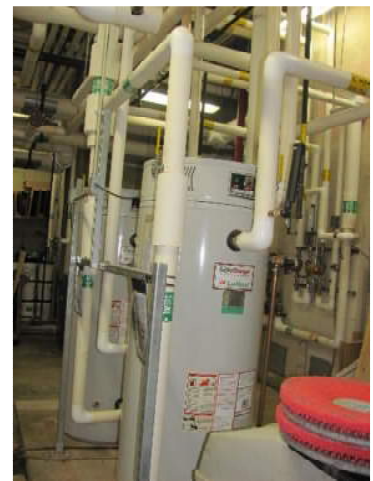
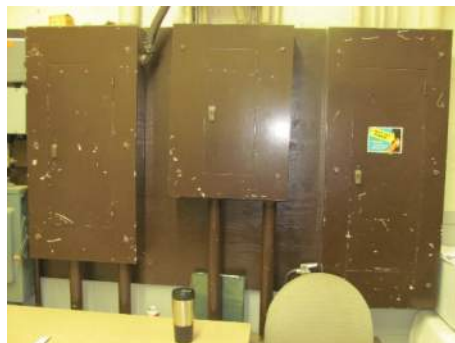
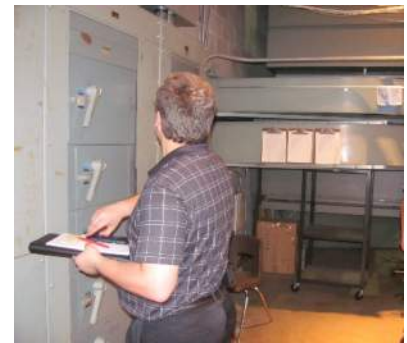
Domestic water heaters are Two (2) 100 gallon, 300 Mbh water heaters in mechanical room serve the building and are in good condition. Water heaters are less than 10 years old.

Panels and distribution in good condition. No issues noted.

Provide tamper proof receptacles in areas required by NEC 406.12

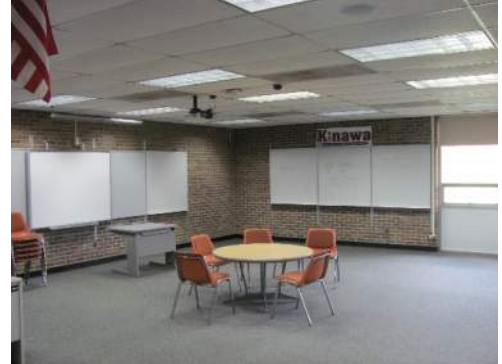
Existing building has T-8 fluorescent lighting installed. Energy savings and better light quality would be realized with new LED lighting. Recommend converting lighting to LED. Presently there is no automatic lighting control within the building. Energy savings would be realized by adding occupancy sensors and automatic lighting control.

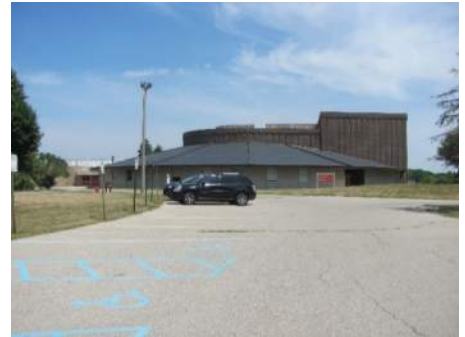
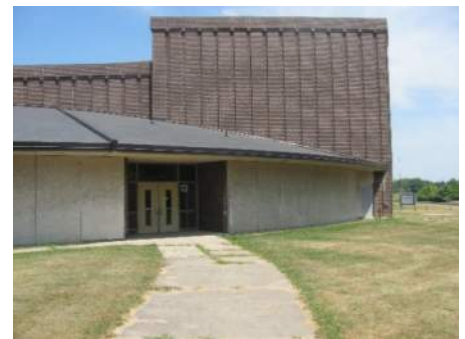
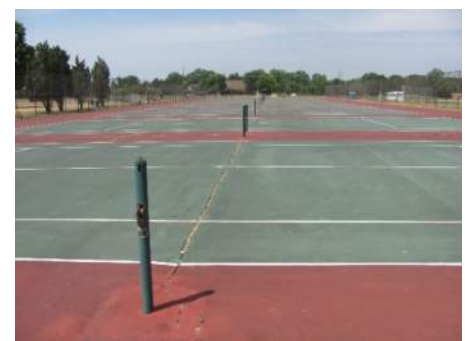
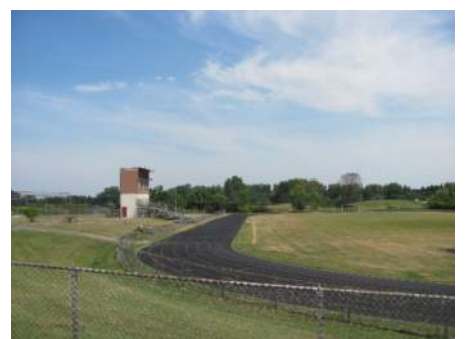
SE entrance and Bus drive were repaved in 2005/2006 and are in good/fair condition. Exhibiting some cracks and wear. Repave in the next 5 - 10 years. Senior Center lot and drive were repaved in 2008/2009 and in good condition. With proper maintenance these lightly traveled surfaces should be serviceable for another 10 years. Main lot/drives on the west were reconfigured and repaved in 2010 and in excellent condition. With proper maintenance these surfaces should be serviceable for another 10 years. Paving at service area is in poor condition and should be repaved. There is a desire to add a new 30 car lot near tennis courts by removing 2 tennis courts.

Site concrete in good/fair condition. Recommend allowance to reconstruct select concrete walks.

Tennis courts w/fencing in fair condition. Resurfaced in 2008. Rebuild with concrete base and new surfacing in 5 - 10 years.

Football field concessions and press booth are in poor condition. Demolish Press Box and replace concessions.

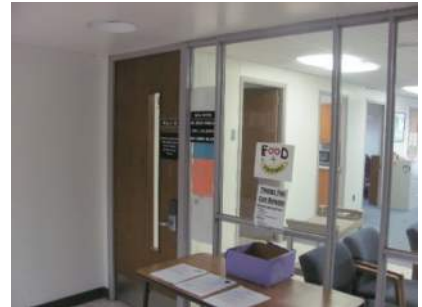
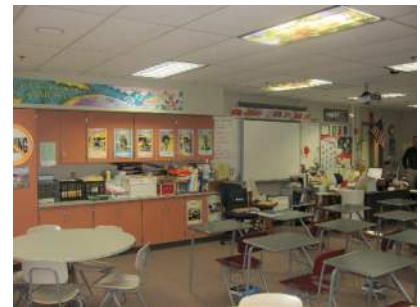
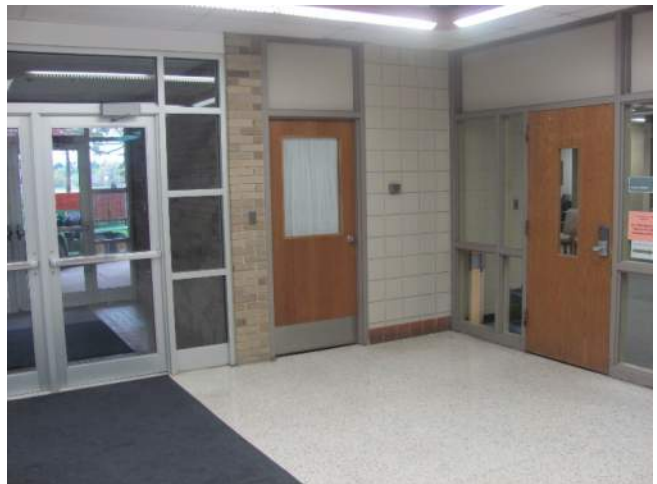
Building has secure entrance with electronic locks and recently installed camera system to control main entrance. The building has a web-based security camera system throughout building. There is not a secure vestibule into the main office. There does not appear to be door contacts to notify when exterior doors are compromised. Consider secure vestibule, security window film and door contacts in program improvements.

- Replace door hardware with BF lever (nic CRs)
- Remodel Toilet Rooms to meet BF
- Add BF counters in classrooms (incl. in casework replacement)

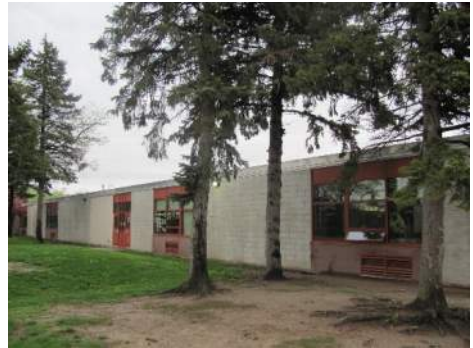
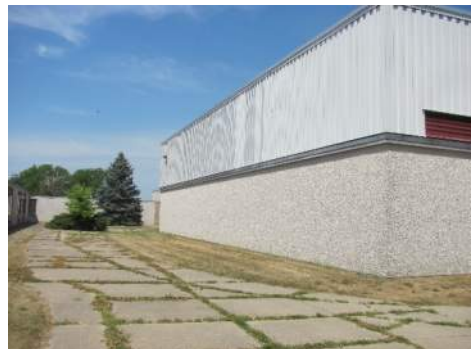
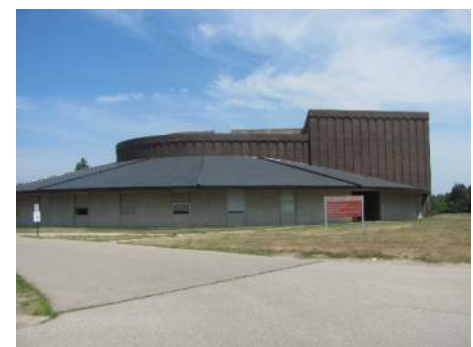
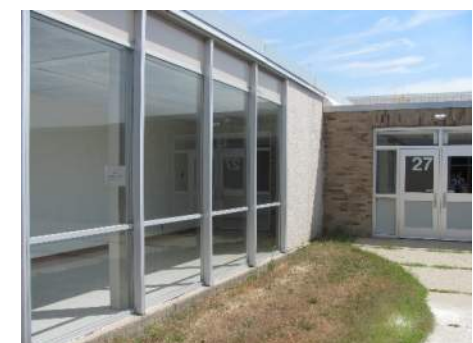
Cooley PVC roof over A, B, office and Media wings were replaced in 2001 and reaching the end of their serviceable life. Recommend replacement in next 1 - 5 years. Bloom/JP Stevens PVC roof over D wing/cafeteria/commons and G wing conference were replaced in 2002 in and reaching the end of their serviceable life. Recommend replacement in next 1 - 5 years. Cooley PVC roof over auditorium, senior center and G Wing were replaced in 2003 and if well maintained should be serviceable until 2023. Royal West/Firestone PVC roof over auditorium (low) and Gym were replaced in 2010 and if well maintained should be serviceable until 2030.

Majority of the envelope is precast panels and ground faced block along with high bay metal siding and some brick veneer on connecting links and upper Auditorium. A & B wing envelope is in good condition with no known issues. Ground faced block should be sealed every 5 years (maintenance). Precast panels are damaged at some corners and should be repaired (maintenance). Joints should be resealed when necessary (no current issues). Finish on the metal panels on high bays are flaking and should be refinish.

Aluminum window systems with integral blinds appear to be in good condition in all units except in C wing (Community Ed and Theater/Music). Replace windows in C wing/auditorium/Music. Some storefront glazing between D and G wings appears to be original single glazed units. Consider replacing with thermally broke insulated aluminum units.

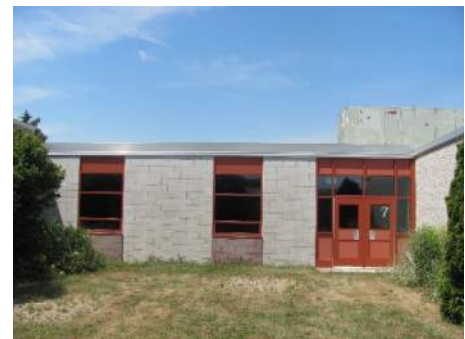
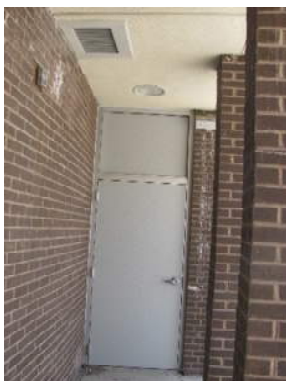
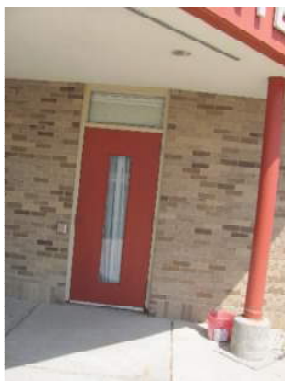
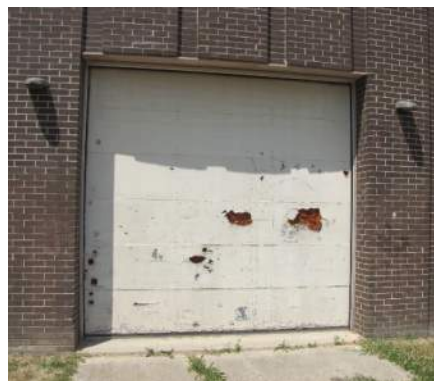
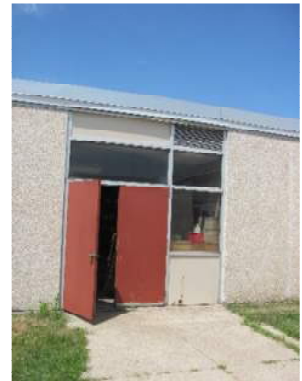
Existing storefront entrances are all in excellent condition. Replace select thermally broke insulated aluminum transoms and sidelights.

Existing HM doors/frames are in fair condition. Eventually HM doors/frames rust and should be replaced w/Alum/FRP doors/frames.

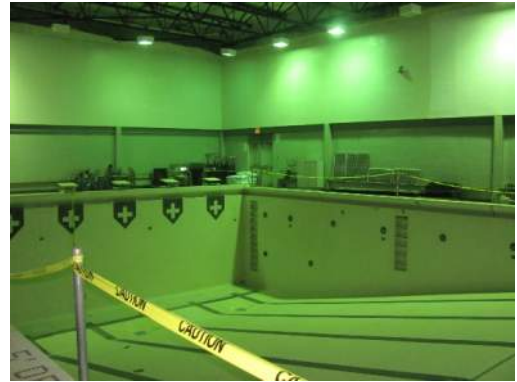
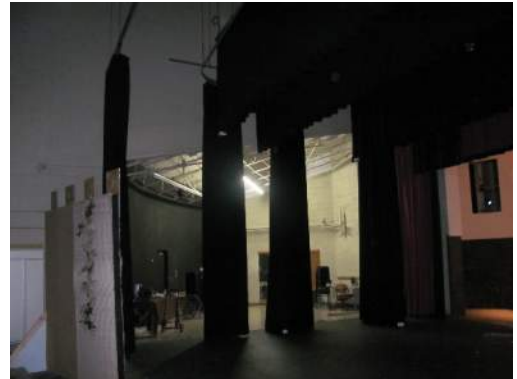
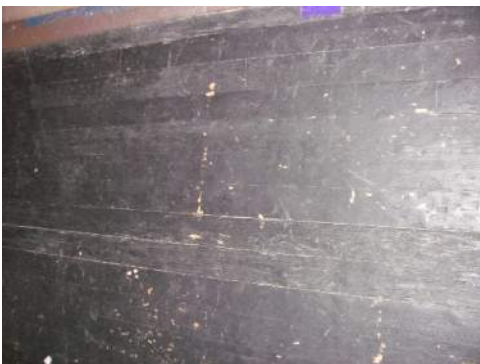
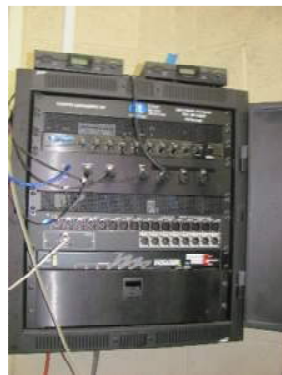
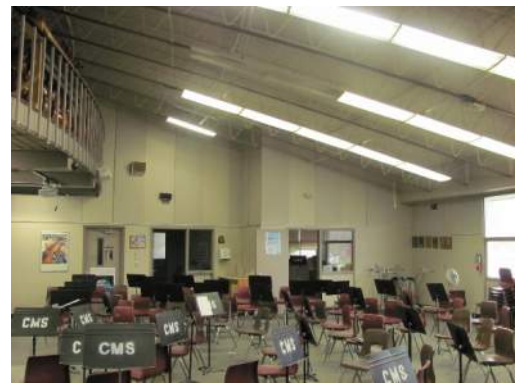
Most of the academic wings are in good condition. The existing pool has been shut down and emptied. Plans are to fill pool in and repurpose as a Multi-purpose room. Remodel/repurpose pool locker rooms. The Fine Arts wing is worn and in need of remodeling (with the exception of the corridor/Lobby ceilings/lighting and toilet rooms). Phase 4 remodeling of the G wing includes locker rooms, storage and multi-purpose room. Refer to program improvements for potential remodeling for program updates.

Close pool, fill in and remodel into a multi-purpose facility and reopen as physical education learning space or redevelop for project-based learning/STEAM space or other function.

Recommend upgrading Fine Arts/Auditorium wing including new flooring, new ceilings, LED lighting, doors, acoustical treatment and music storage in classrooms, stage lighting, drapery, sound/AV and stage flooring.

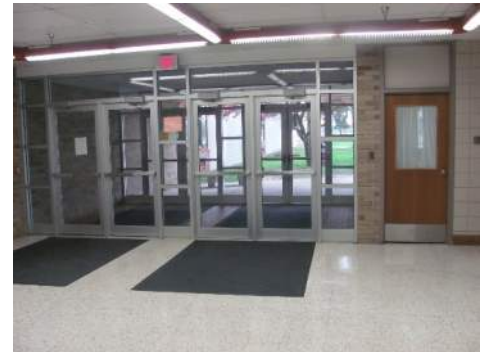
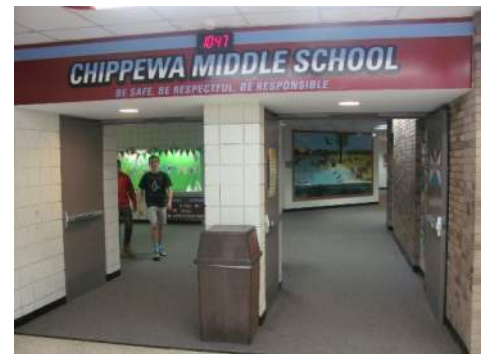
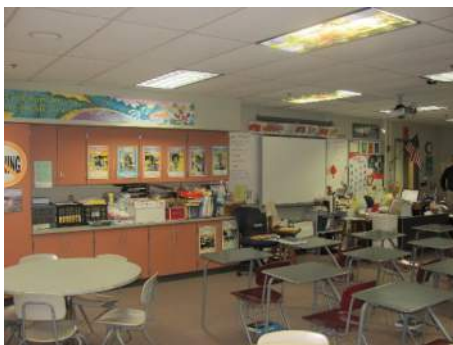
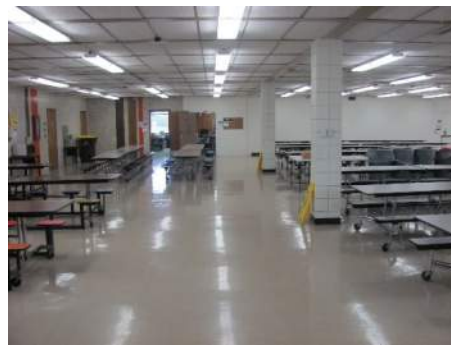
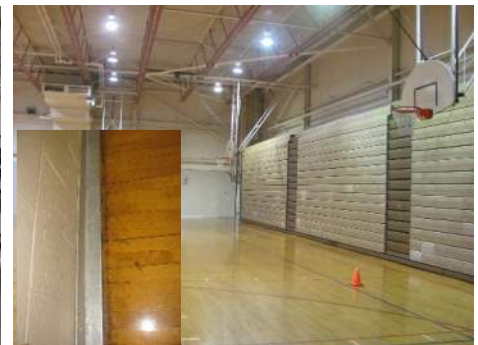
Terrazzo and hard tile flooring in excellent condition. No issues noted.

Cafeteria VCT flooring is in poor condition. Recommend replacing with polished concrete.

Replace sheet flooring in Art Room. Consider polished concrete.

Main Gym flooring is worn and should be replaced. Auxiliary gym wood floor is in good condition.

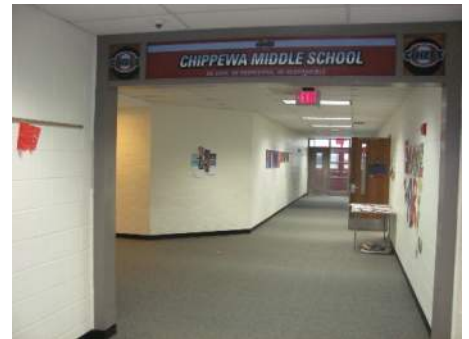
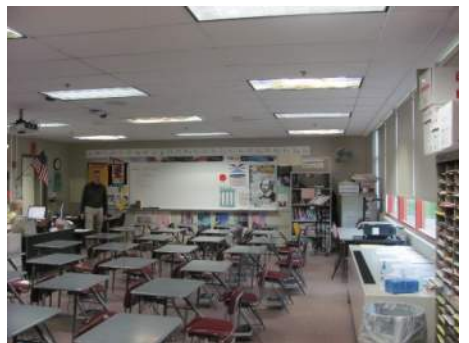
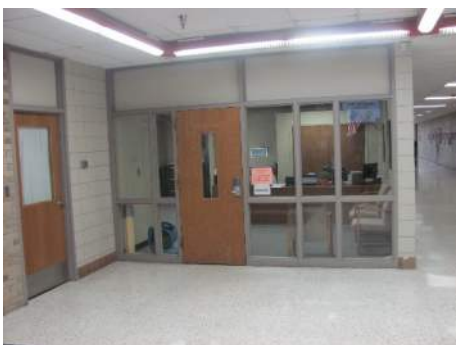
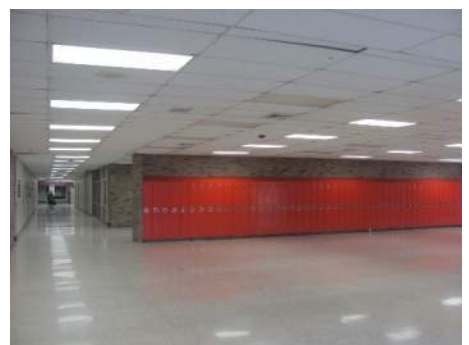
Majority of interior wood doors are in excellent condition. District installed electronic access locks at all classrooms. Recommend allowance to replace existing damaged interior wood doors.

Corridor Lockers are in fair condition. Some rust will occur in bottoms and some doors are out of alignment. With good maintenance, lockers should be serviceable for next 5 -10 years. PE/Team lockers are in good condition with recent and 2018 G wing remodeling. Pool lockers will be replaced in remodel/repurpose of pool.

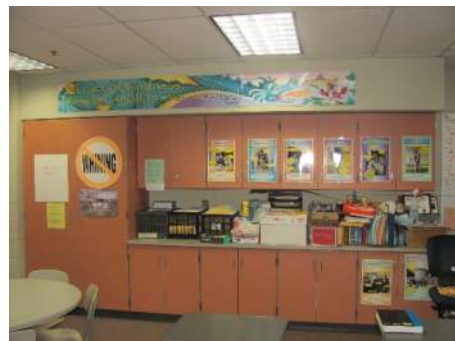
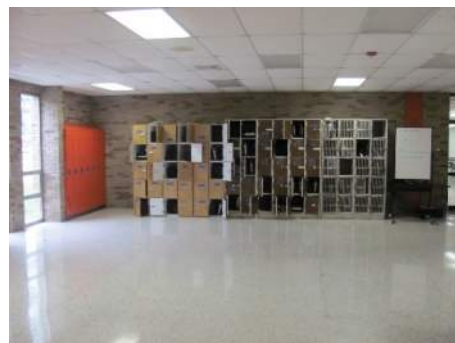
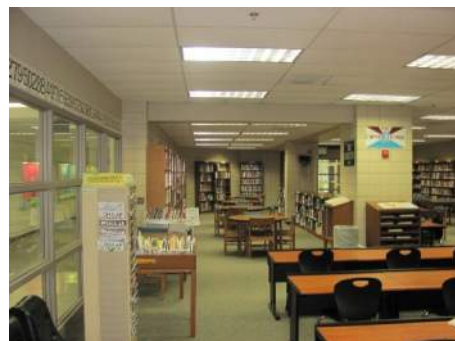
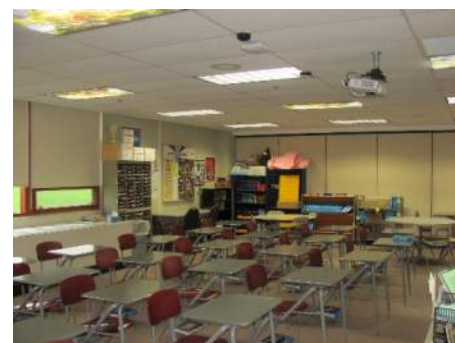
Majority of laminate clad casework is in good condition with the exception of some oversized doors and some countertop delamination in places. Recommend replacement allowance in 5 years and in 5 - 10 years.

Science room casework/tables/stations in fair condition. With good maintenance, they should be serviceable for the next 5+ years. Recommend replacement in 5 - 10 years

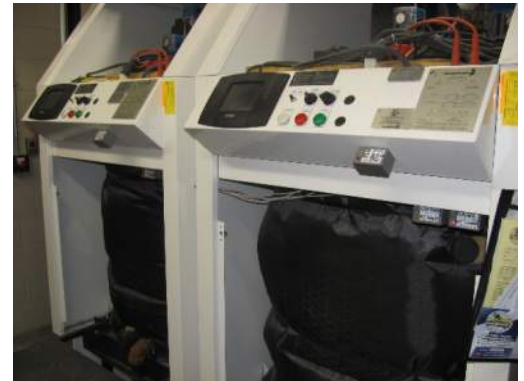
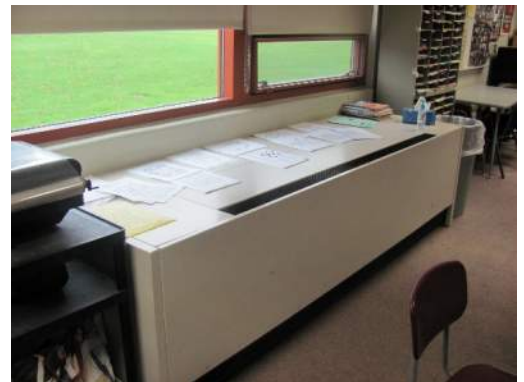
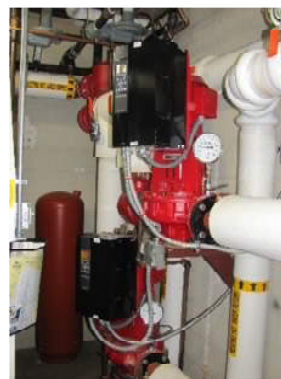
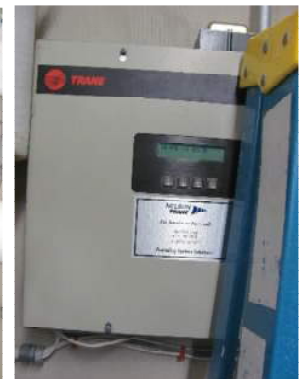
Replace noisy classroom unit ventilators (A&B).

Exhaust systems are original to building (60 years old) and should be replaced.

Replace AHUs serving Auditorium, band, and choir areas (add A/C)

Replace heating only (HW) AHU serving science rooms (add A/C).

Replace Admin rooftop unit and add VAV boxes for more occupant control.

Replace DX cooling, gas heat rooftop units.

Replace existing pneumatic temperature controls with new DDC system to communicate with district's system.

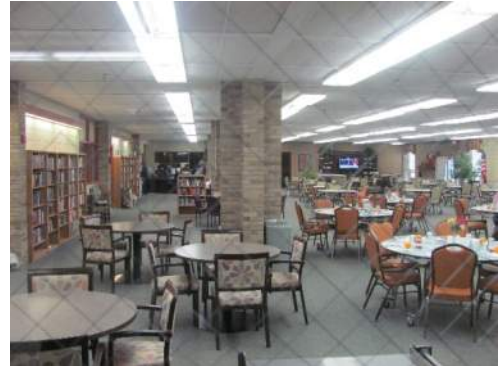
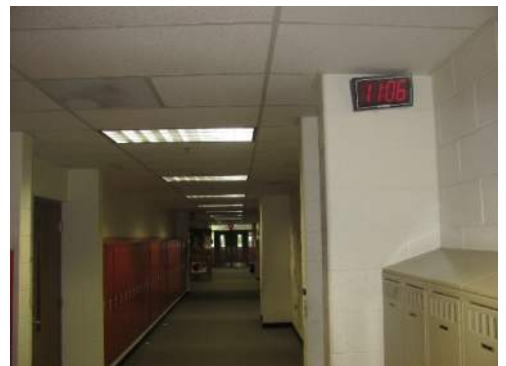
Recommend converting lighting to LED. Presently there is no automatic lighting control within the building. Energy savings would be realized by adding occupancy sensors and automatic lighting control.

The original clock system is inadequate and recommended for replacement.

Recommend replacing existing site lights on the east with new LED site lighting on new poles.

Recommend replacing existing HID exterior building fixtures with new LED fixtures.

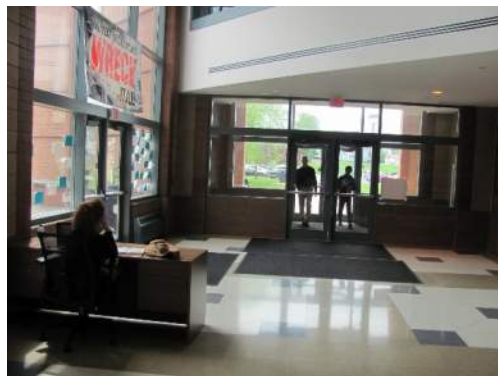
Building has secure entrance with electronic locks and recently installed camera system to control main entrance. The building has a web-based security camera system throughout building. There is not a secure vestibule into the main office. There does not appear to be door contacts to notify when exterior doors are compromised. Consider secure vestibule, security window film and door contacts in program improvements.

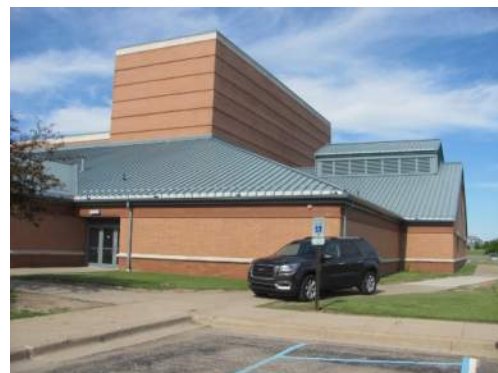
Metal roof, gutters, downspouts over classroom wings, around pool and PAC in excellent condition. No issues noted. McDonald/Carlisle PVC roof over PAC was replaced in 2011 and if well maintained, should be serviceable until 2026 - 2031. McDonald/Firestone PVC roof over gyms was replaced in 2007 in and if well maintained should be serviceable until 2022 - 2027. Royal West/Firestone PVC roof over pool, office and central area was replaced in 2008 and if well maintained should be serviceable until 2023 - 2028.

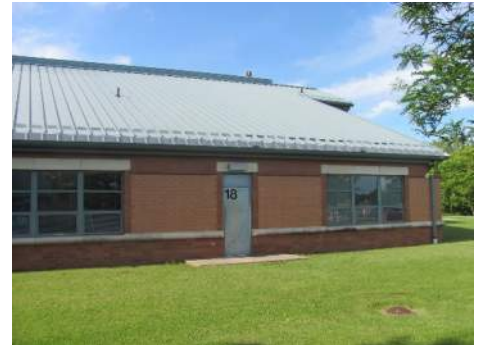
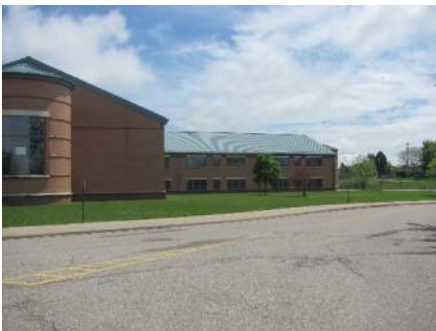
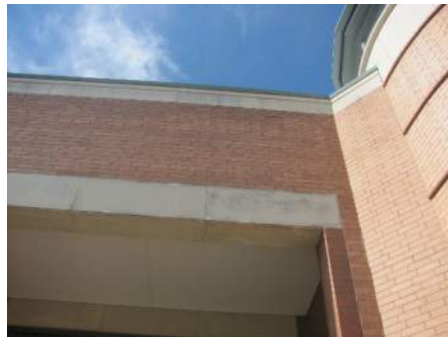
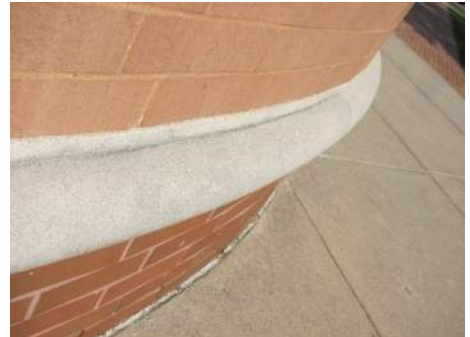
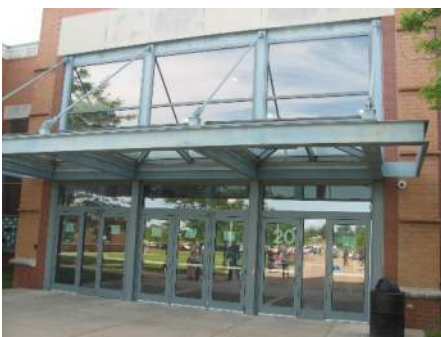
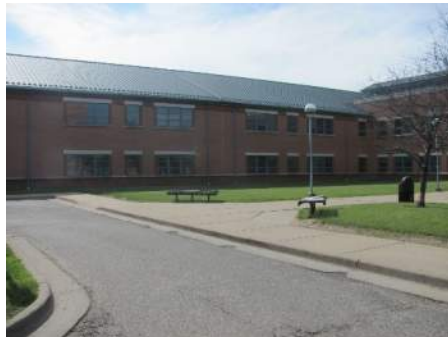
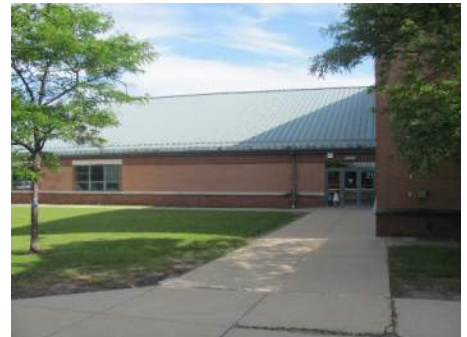
Jumbo brick envelope in excellent condition. No issues noted. Rounded cast sills are covered with silt/dirt. Power wash and seal.

Original colored aluminum insulated windows with integral blinds are in excellent condition. No issues noted.

Existing storefront entrances are all in excellent condition. No issues noted.

Existing HM doors/frames are in fair condition. Eventually HM doors/frames rust and should be replaced w/Alum/FRP doors/frames.
