# Okemos Public Schools

Facilities Assessment

September 2018

# Kingscott

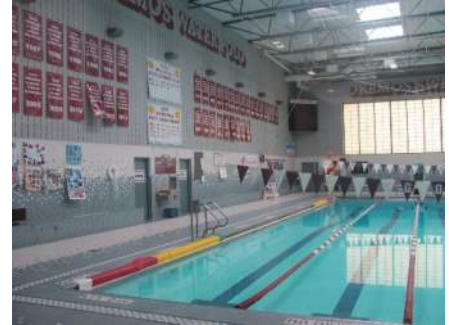
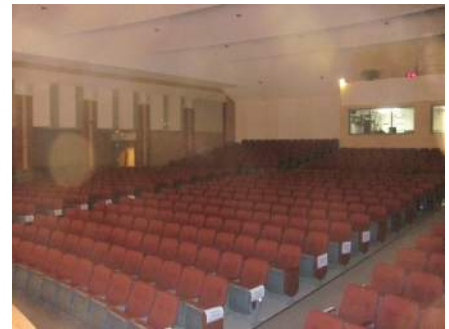
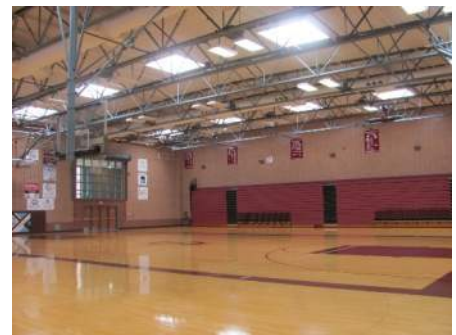
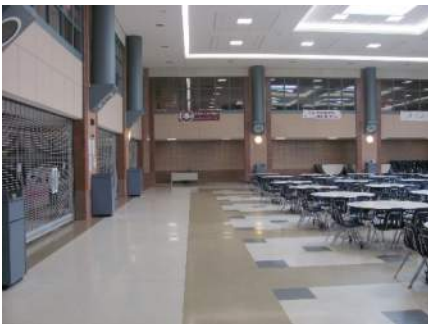
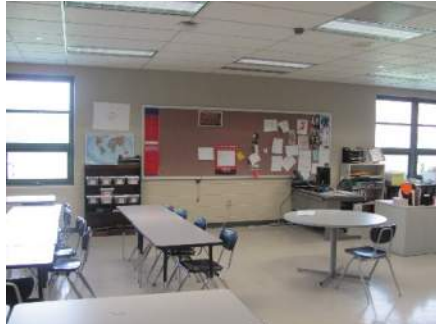
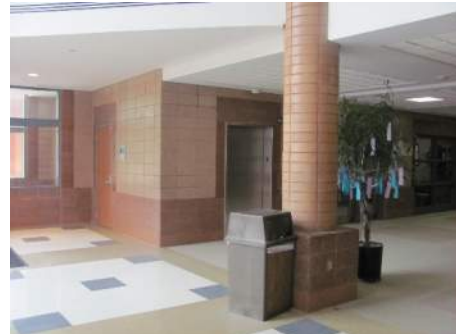
Corrosion apparent in Natatorium skylights, some equipment and HM doors. Provide a lump sum to replace equipment.

**Flooring** is a mix of terrazzo, carpet, vinyl composition tile (VCT), wood sports flooring, quarry and ceramic mosaic tile all mainly in good condition. Carpet in select classrooms/areas is worn and nearing the end of its serviceable life. The district has done a good job of selectively replacing carpet throughout all buildings through their sinking fund.

Terrazzo and hard tile flooring in excellent condition. No issues noted.

Main Gym and auxiliary gym in excellent condition. No issues noted.

Replace sheet flooring in Art Room. Consider polished concrete.

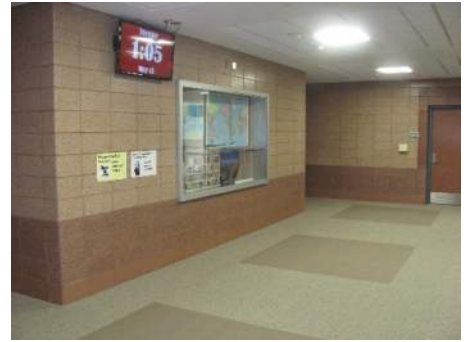
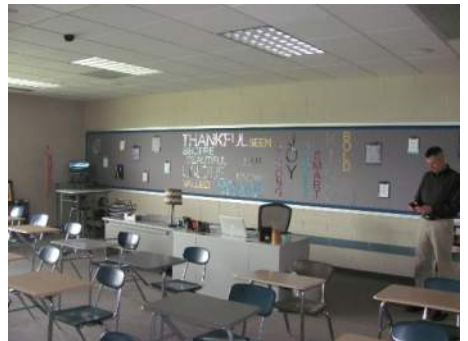
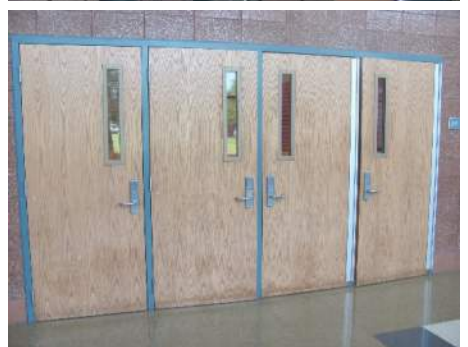
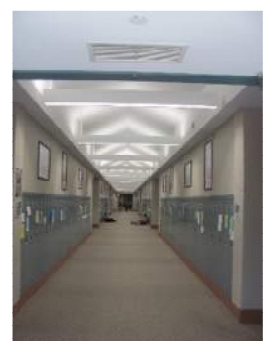
Majority of public space walls are a very durable burnished block with timeless colors in excellent condition. These should serve well into the future.

Classroom spaces are a combination of painted gypsum board and CMU and in good condition. With continuing good maintenance, these shall serve well into the future.

Restroom and lockerroom walls are generally glazed tile/painted gypsum board/CMU and in excellent condition. No issues noted.

Acoustical panel ceilings and grid are in excellent condition. No issues noted. Exposed metal acoustical deck ceiling in Gyms in excellent condition. No issues noted. Some gypsum board ceilings were observed to be damaged from water. Recommend replacement.

Majority of interior wood doors are in excellent condition. District installed electronic access locks at all classrooms. Recommend allowance to replace existing interior wood doors in high abuse areas such as gym/cafeteria areas.

Corridor Lockers are in fair condition. Some rust will occur in bottoms and some doors are out of alignment. With good maintenance, lockers should be serviceable for next 10+ years. PE Locker Rooms renovated in 2013 and in good condition. Team lockers are in fair condition. Typically PE lockers are in a high abuse environment. Recommend replacing Team in next 5. Pool lockers should be replaced in pool upgrades.

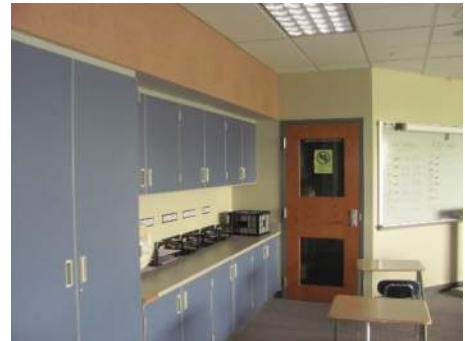
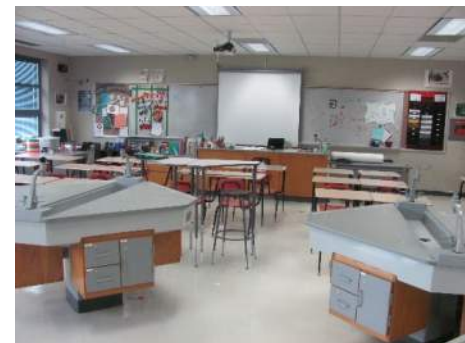
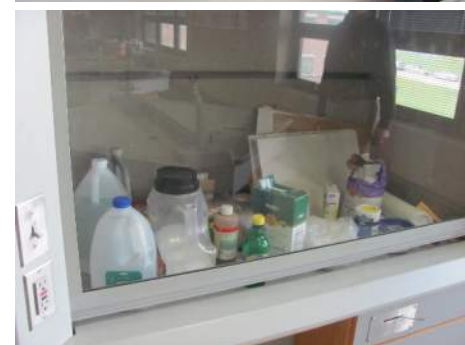
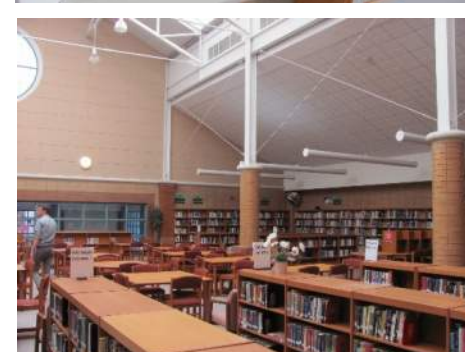
Majority of laminate clad casework is in good condition with the exception of some oversized doors and some countertop delamination in places. Recommend replacement allowance in 5 years and in 5 - 10 years.

Science room casework/tables/stations in fair condition. With good maintenance, they should be serviceable for the next 5+ years. Recommend replacement in 5 - 10 years. Existing fume hoods in chemistry rooms do not appear to be used. Code requires expensive continuous 100% air exchange. Recommend removing 5 of 6 units.

Music room/corridor instrument storage in fair to poor condition. Recommend replacement in phases 5 years and 5 - 10 years.

Acoustical wall treatments in sensitive areas such as music, gyms, cafeteria in excellent condition and appear to control noise well. It was noted modifications to the rear house of the PAC were made to improve reverberation times. Recommend acoustician model space for further improvements. Provide lump sum allowance.

Most FS equipment will be maintained by FS budget. Add a double deck combi-oven under the existing bakery hood.

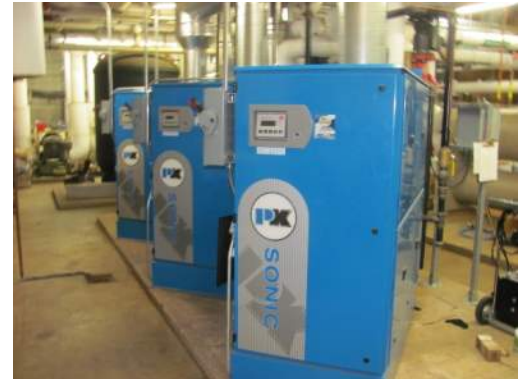
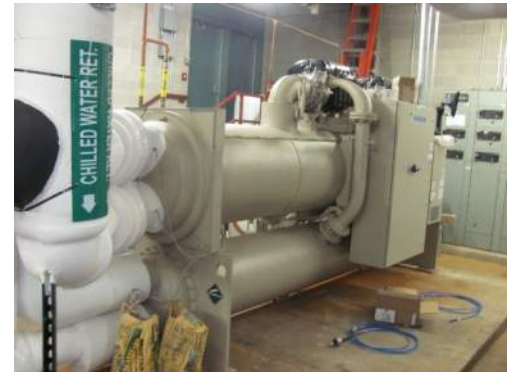
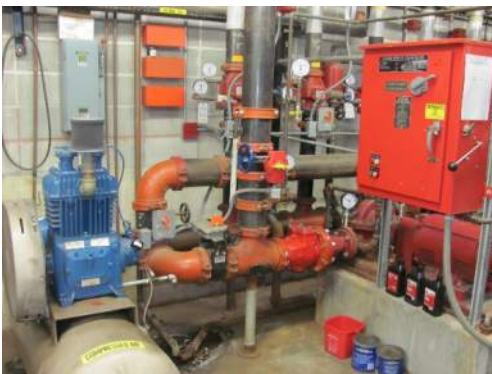
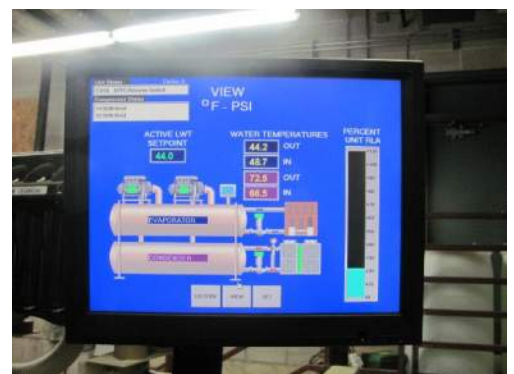
In general, the existing mechanical systems have been very well maintained through wise sinking fund investments and are in good condition. Continue normal maintenance procedures to maximize life cycle.

Boilers and associated pumps replaced in 2014, no work required.

Central station air handling units provide heating and cooling throughout the building. Units are 20+ years old and in good condition.

Exhaust systems are original to building and in good condition, no work required.

Building is on district temperature control system, no work required.

Add/replace CO2 sensors.

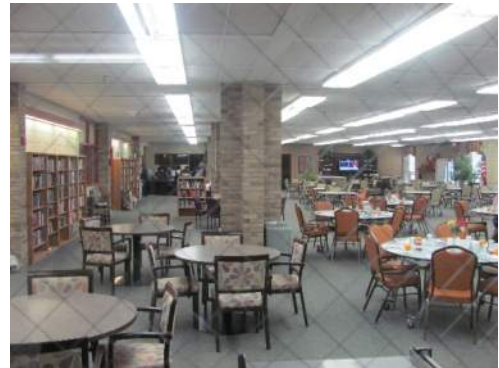
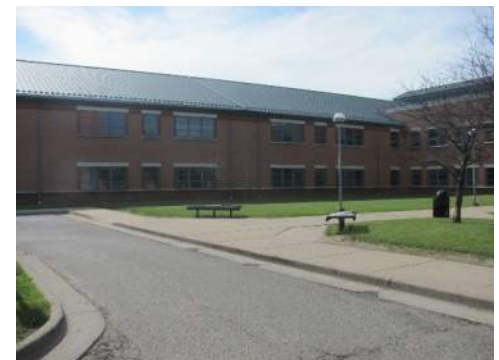
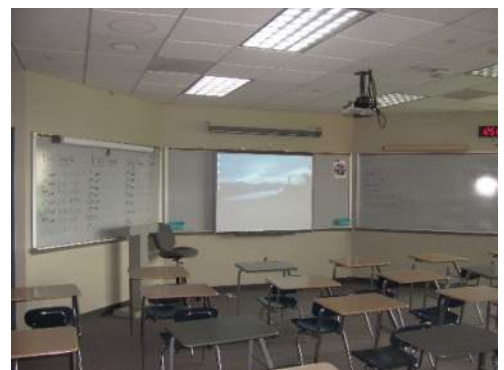
Existing fluorescent lighting was converted to LED in approximately 75% of the building. Convert/replace remaining 25% with LED (In Pool, PE & FA wing). Energy savings and better light quality would be realized with new LED lighting in these areas as well. Recommend converting lighting to LED. Presently there is no automatic lighting control within the building. Energy savings would be realized by adding occupancy sensors and automatic lighting control.

The original clock system is inadequate and recommended for replacement.

Recommend replacing existing site lights with new LED site lighting on existing poles.

Recommend replacing existing HID exterior building fixtures with new LED fixtures.

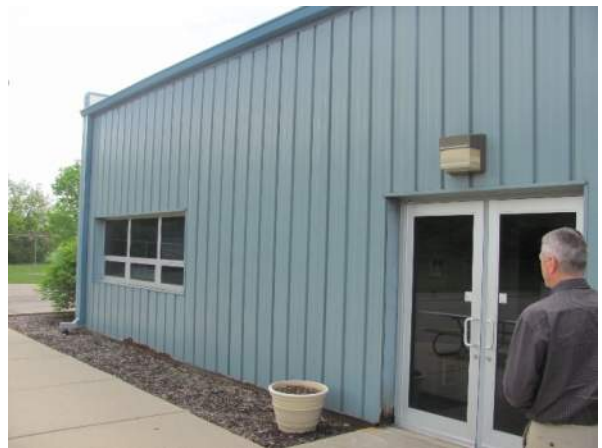
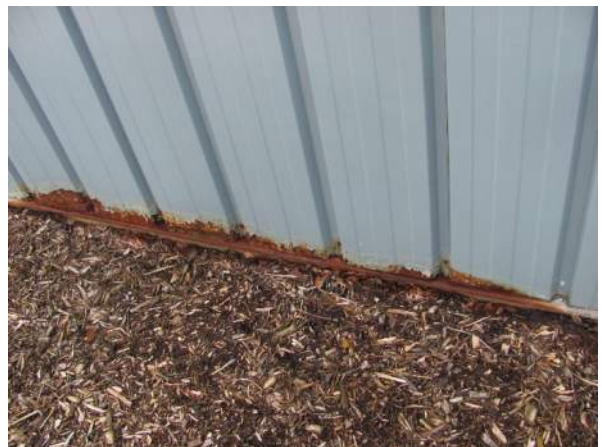
Roof was replaced in 2014 and along with gutters/downspouts is in excellent condition. Roof should remain serviceable for over 20 years.

Metal siding is in good condition with the exception of a few rust spots at ground level. Recommend removing rust and repainting (maintenance).

Existing facility is in excellent condition. No issues noted.

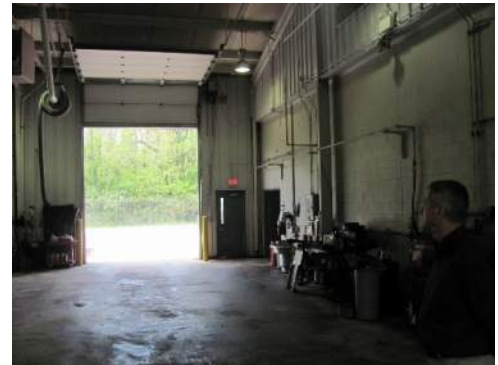
There is currently no bus lift. Recommend adding a bus lift to one bay.

The wash bay is currently a manual system. Recommend a new automated wash system.

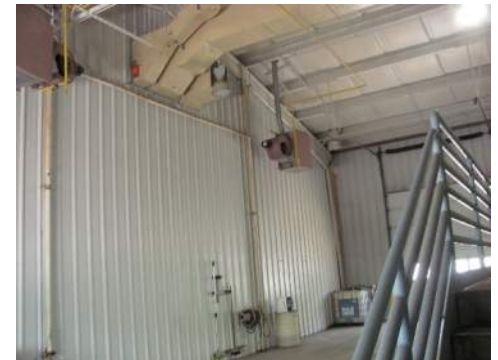
Rework floor / floor drains in work bay (water doesn't go to drains).

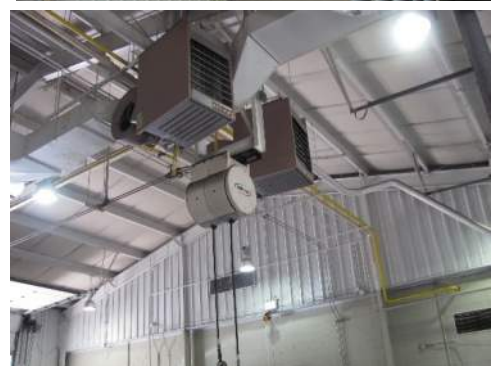
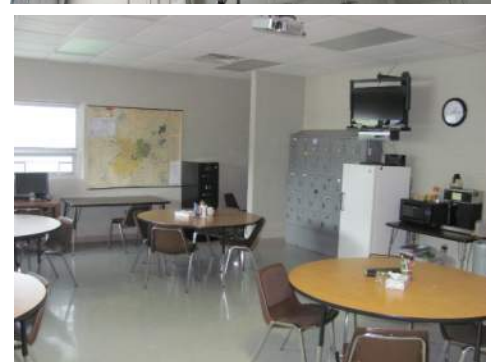
Existing building has T-8 fluorescent lighting installed. Energy savings and better light quality would be realized with new LED lighting. Recommend converting lighting to LED. Presently there is no automatic lighting control within the building. Energy savings would be realized by adding occupancy sensors and automatic lighting control.

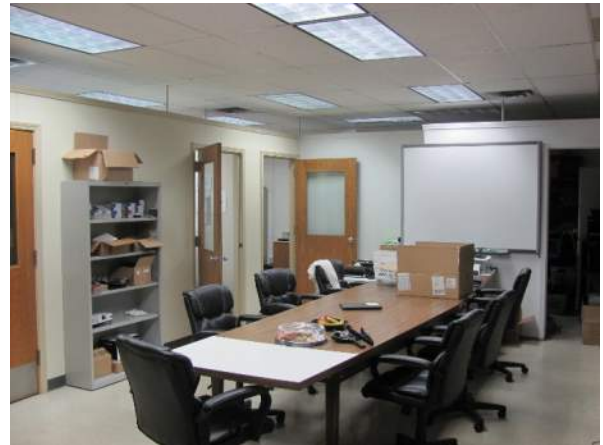
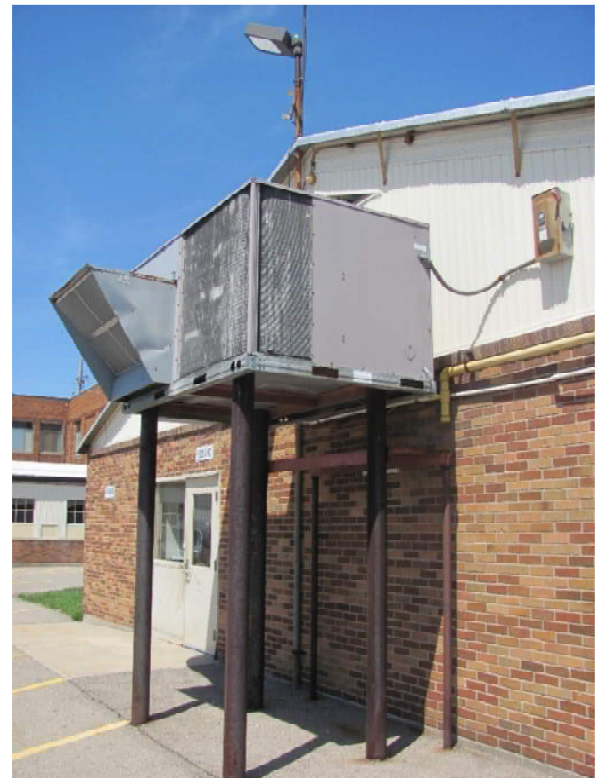
Heating plant - Replace post-mounted rooftop unit at building exterior.

Ground mounted Liebert air-cooled condensing unit appears new. No issues noted.

Replace existing pneumatic temperature controls with new DDC system to communicate with district's system.

Route heating piping from Central, thru tunnel, to Operations building.

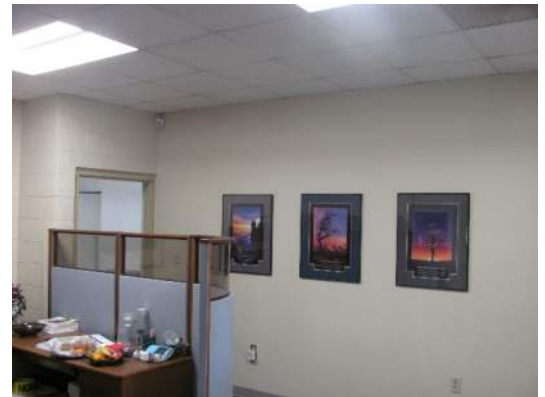
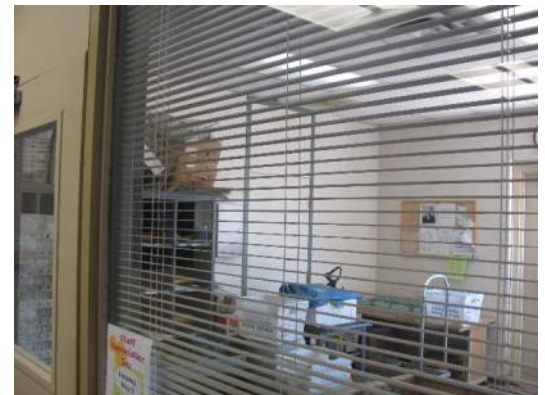
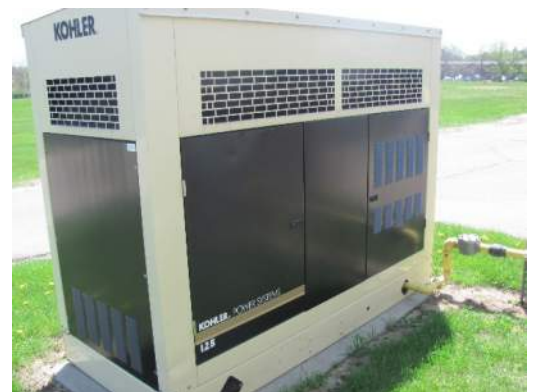
Service and distribution - Replace original panelboards remaining in building.

Existing building has T-8 fluorescent lighting installed. Energy savings and better light quality would be realized with new LED lighting. Recommend converting lighting to LED. Presently there is no automatic lighting control within the building. Energy savings would be realized by adding occupancy sensors and automatic lighting control.

Provide code compliant fire alarm system.

Existing Kohler Generator for District data systems appears to be in good condition. No issues noted.
